**Visual Pro Home Inspections**  
6239 Eastmoor Road  
Bloomfield Hills MI 48301  
248-688-7918  
vincentcameron@VisualProHomeInspections.com

**Report: 8078**

## **Confidential Inspection Report**

**2450**  
**West Bloomfield, MI 48324**

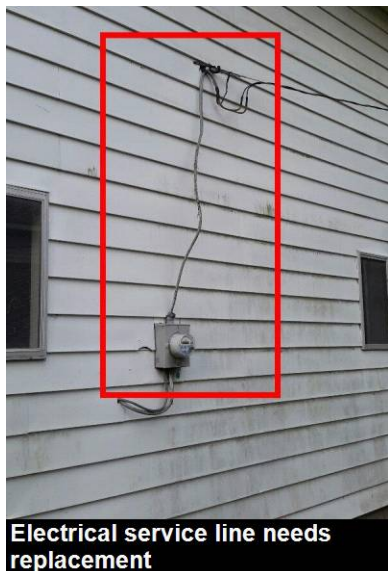
Electrical Service line is frayed and needs replacement from the line connection down to the meter.

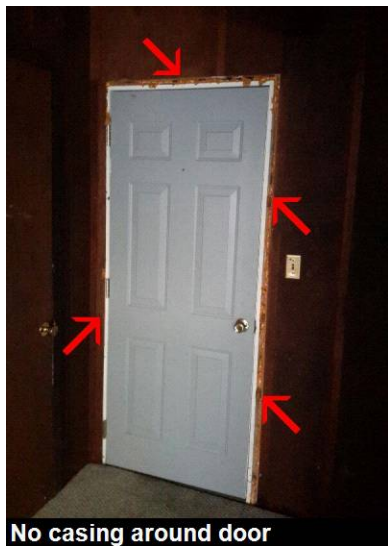
Missing casing on inside. Door drags on carpet.

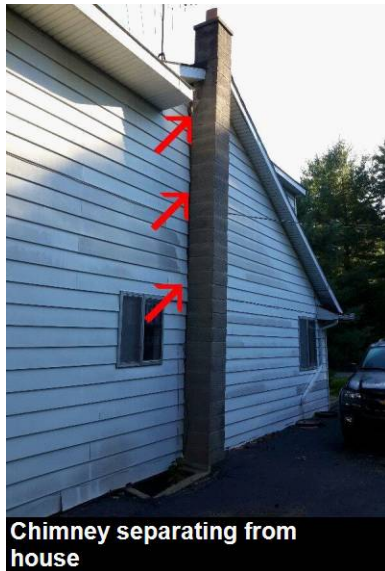
**Chimney separating from house**

Chimney is constructed of concrete block materials. Flue stack separation is noted. Foundation that holds chimney has settled causing chimney to pull away from home. Most likely to continue to fall away creating a safety hazard. Best repair scenario would be to remove entire chimney and repair foundation below or install a new B-vent in its place with a new surround.

Recommend repair and further inspection prior to use.

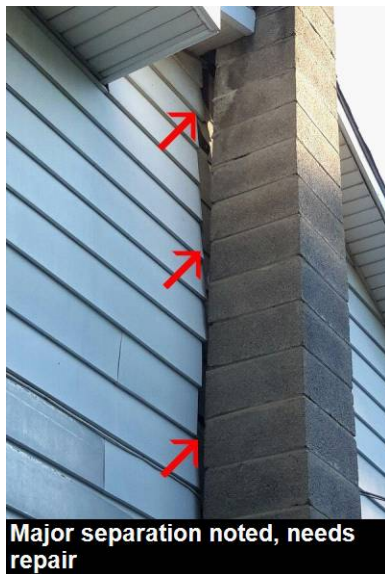
**Major separation noted, needs repair**

Chimney is constructed of concrete block materials. Flue stack separation is noted. Foundation that holds chimney has settled causing chimney to pull away from home. Most likely to continue to fall away creating a safety hazard. Best repair scenario would be to remove entire chimney and repair foundation below or install a new B-vent in its place with a new surround. Recommend repair and further inspection prior to use.

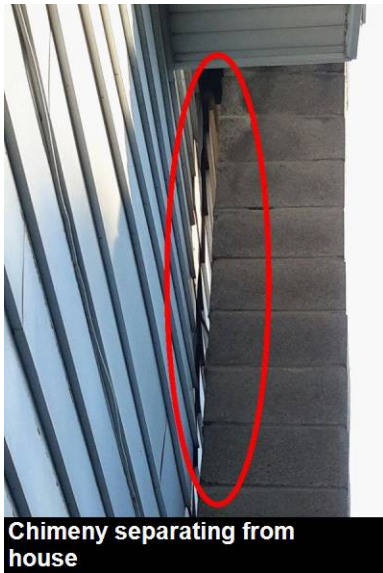
Chimney is constructed of concrete block materials. Recommend repair and further inspection prior to use.

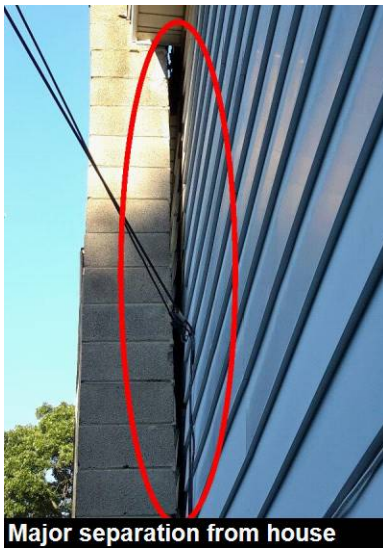
Chimney is constructed of concrete block materials. Recommend repair and further inspection prior to use.

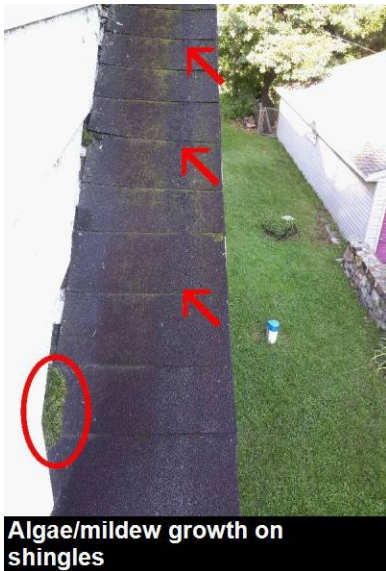
Moderate mildew growth can be lightened by the gentle application of bleach. Be careful not to loosen the mineralized granules.

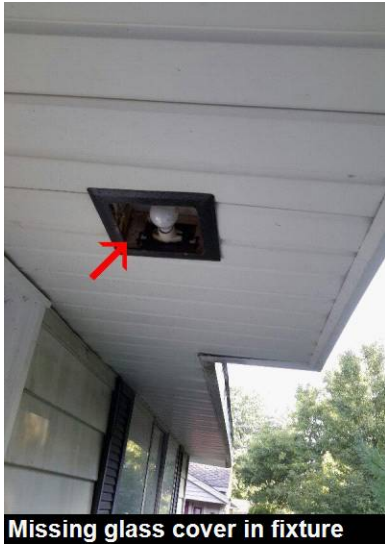
Missing glass in light cover.

**Missing glass cover in fixture**

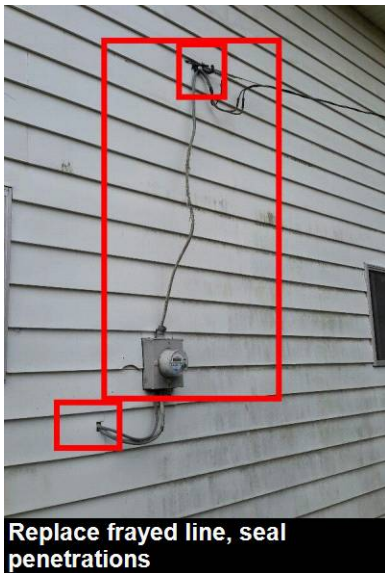
Overhead, 110/220 Volt, Circuit breakers, Damage/Defects noted:

Damage/Defects noted: seal penetration in wall.

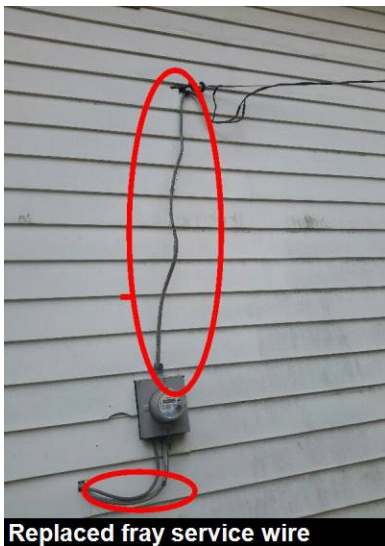
Damage/Defects noted: frayed service wire needs to be replaced.

**Replaced fray service wire**

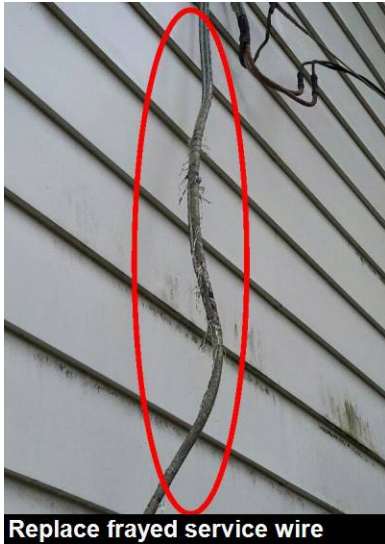
Damage/Defects noted: frayed service wire needs to be replaced.

**Replace frayed service wire**

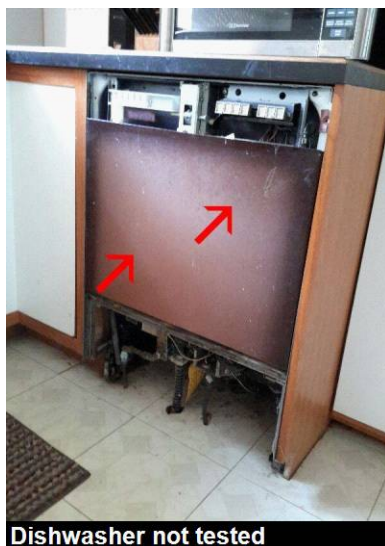
Not operational, Not tested.

Dishwasher not tested

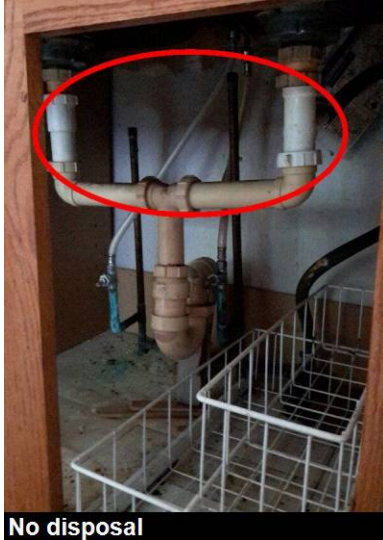
None installed.

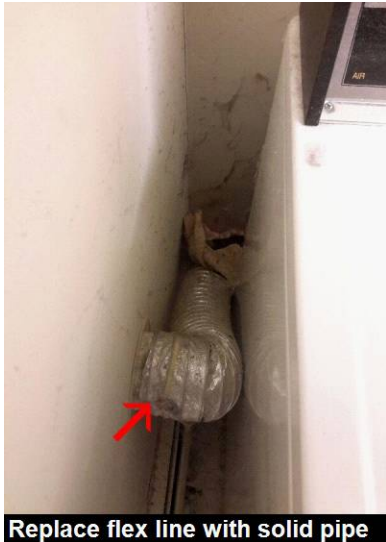
A dryer vent is provided, Replace flexible dryer vent with solid pipe.

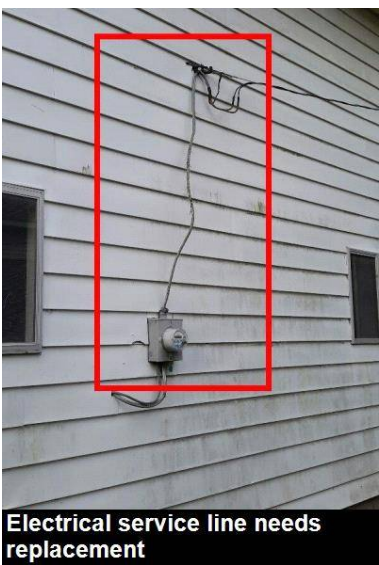
Missing light bulb

Electrical service line needs replacement

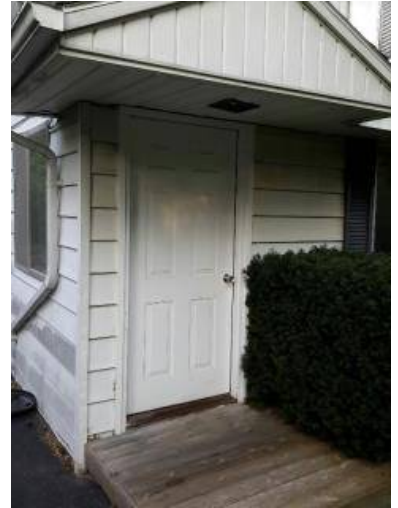
- ☒ ☐ ☐ Metal, Hardware is operational, Doorframes are not square. Some binding is noted, Doorbell button is missing.

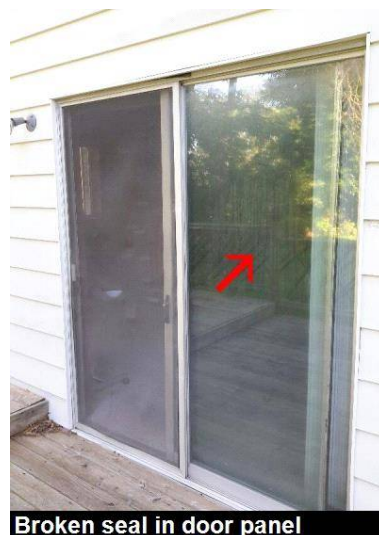
- ☐ ☒ ☐ Metal, double doors, with glass.  
Broken seal in stationary panel.

Broken seal in door panel

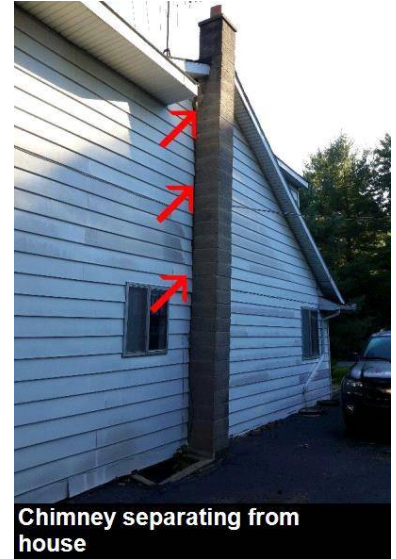
- ☐ ☐ ☒ Chimney is constructed of concrete block materials. Flue stack separation is noted. Foundation that holds chimney has settled causing chimney to pull away from home. Most likely to continue to fall away creating a safety hazard. Best repair scenario would be to remove entire chimney and repair foundation below or install a new B-vent in its place with a new surround. Recommend repair and further inspection prior to use.

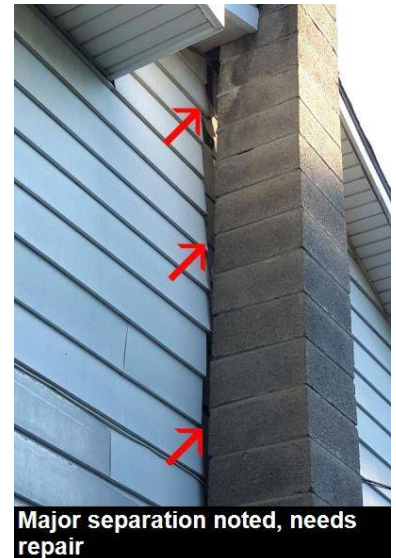
- ☐ ☐ ☒ Chimney is constructed of concrete block materials. Flue stack separation is noted. Foundation that holds chimney has settled causing chimney to pull away from home. Most likely to continue to fall away creating a safety hazard. Best repair scenario would be to remove entire chimney and repair foundation below or install a new B-vent in its place with a new surround. Recommend repair and further inspection prior to use.

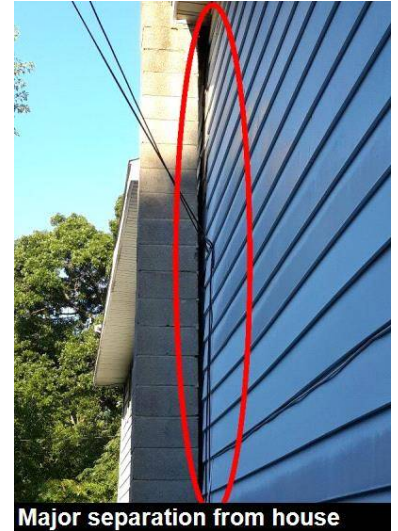
- ☐ ☐ ☒ Chimney is constructed of concrete block materials. Recommend repair and further inspection prior to use.

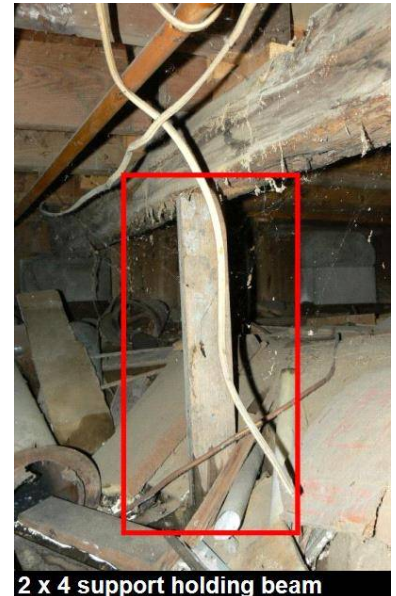
- ☐ ☐ ☒ The main beam is in a condition that warrants replacement or repair. A 2 X 4 is being used to support a beam. This is not common practice. Earth to wood contact is noted along with moderated rot. The main beam is a single large dimension wood board.

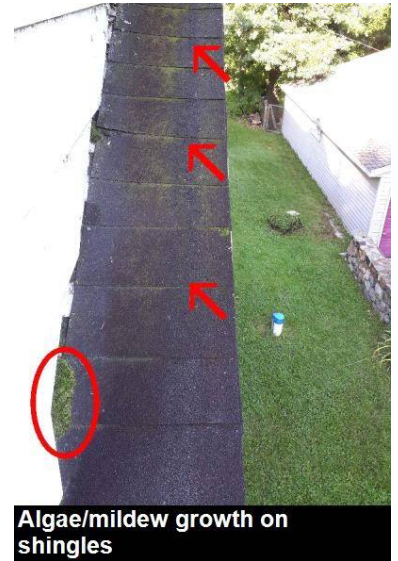
- ☐ ☐ ☒ Moderate mildew growth can be lightened by the gentle application of bleach. Be careful not to loosen the mineralized granules.

Algae/mildew growth on shingles

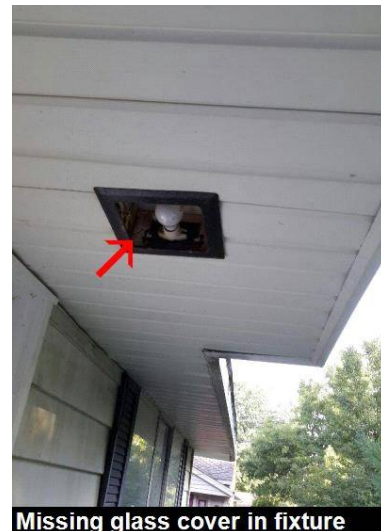
- ☐ ☐ ☒ Missing glass in light cover.

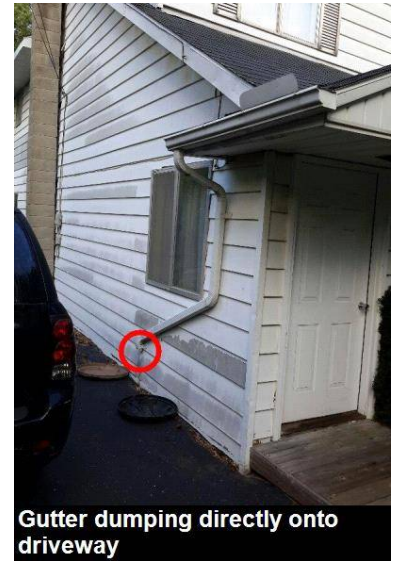
- ☐ ☒ ☐ Gutters and downspout materials are aluminum. Building is partially guttered. Extend downspouts to route rainwater away from the building. Gutters are discharging water near the foundation.

- OK MM RR  
☐ ☒ ☐ Consider installing gutters and downspouts to help with site drainage.

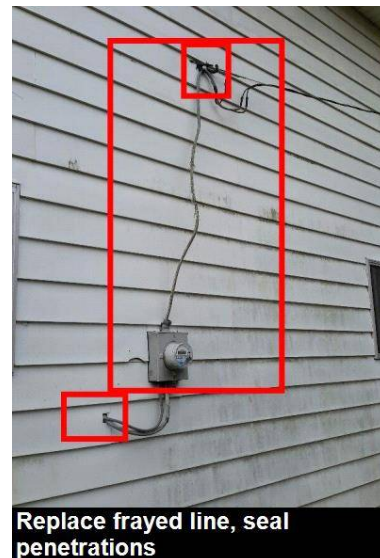
Overhead, 110/220 Volt, Circuit breakers, Damage/Defects noted:

Replace frayed line, seal penetrations

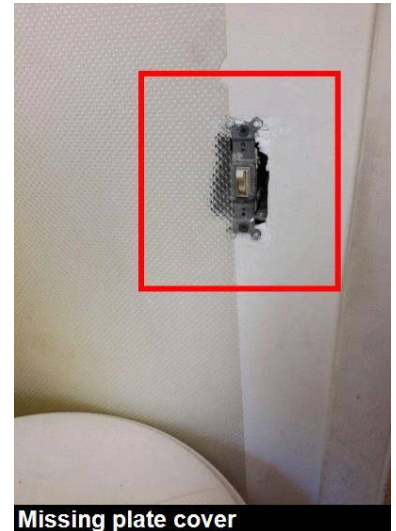
- ☐ ☒ ☐ Switch cover is damaged, needs replacement, Functional.

Missing plate cover

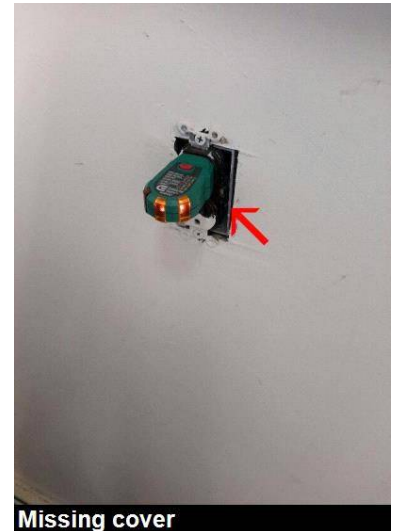
- ☐ ☒ ☐ A representative sampling of switches and outlets was tested. As a whole, outlets and switches throughout the room are in serviceable condition. Missing or damaged cover plates viewed.

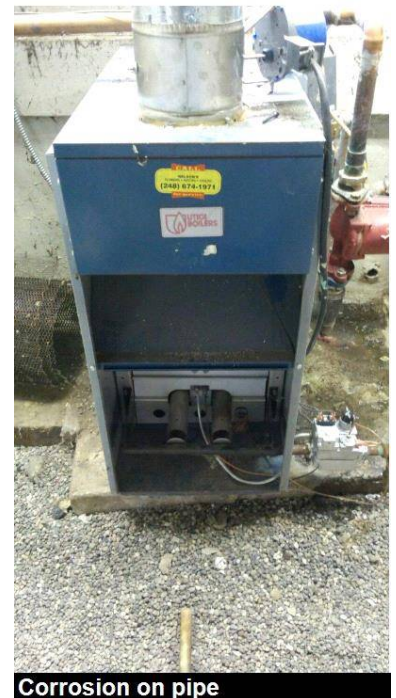
Corrosion on main pipe.

Corrosion on pipe

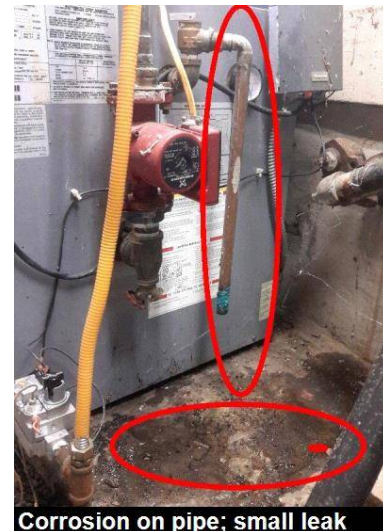
☐ ☒ ☐ Corrosion is noted, Small leak.

Corrosion on pipe; small leak

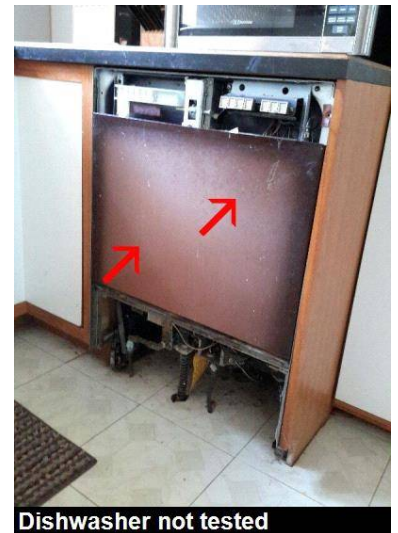
- OK MM RR  
☐ ☐ ☒ Not operational, Not tested.

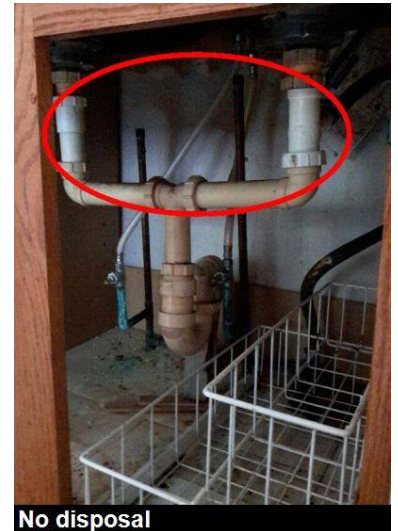
☐ ☐ ☒ None installed.

No disposal

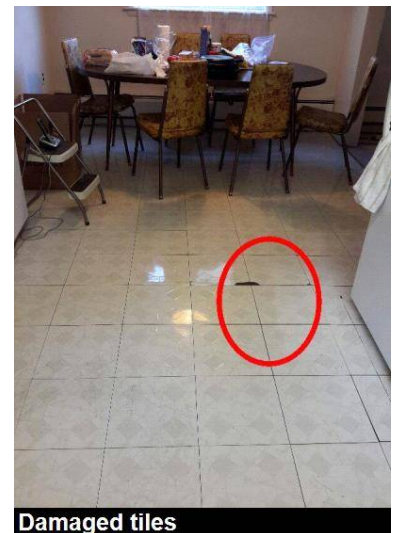
- ☐ ☒ ☐ General condition appears serviceable, The floor covering material is Vinyl planks/tiles. Fair - Material is worn, with some age. The floor in this room is in need of some attention or repair.

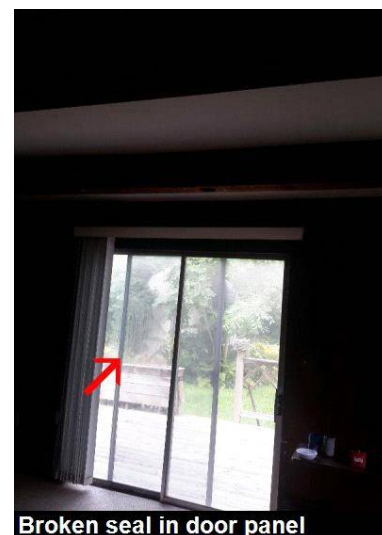
General condition appears  
serviceable, Hardware operational,  
Broken seal, damaged screening.

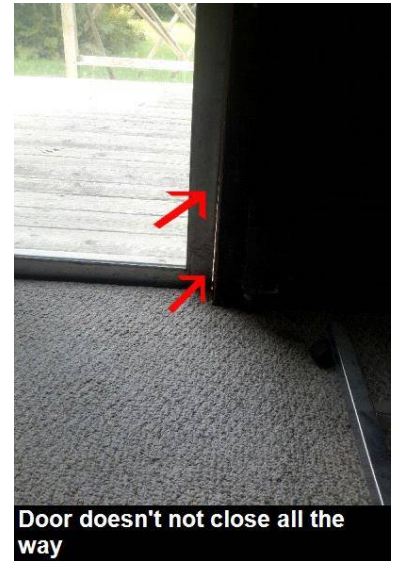
☐ ☒ ☐ Door doesn't seal completely.

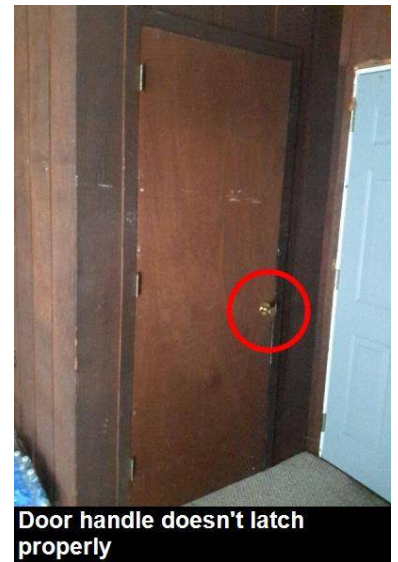
General condition appears serviceable, Hardware operational, Door hardware needs adjustment or repair, as the latch or strike plate needs adjustment so that the door will latch correctly.

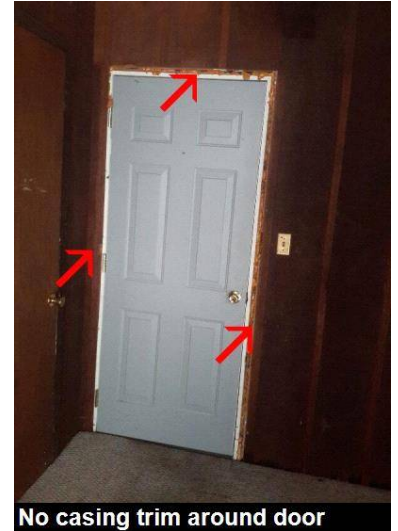
- ☐ ☒ ☐ General condition appears serviceable, Hardware operational, Missing casing around the door.

No casing trim around door

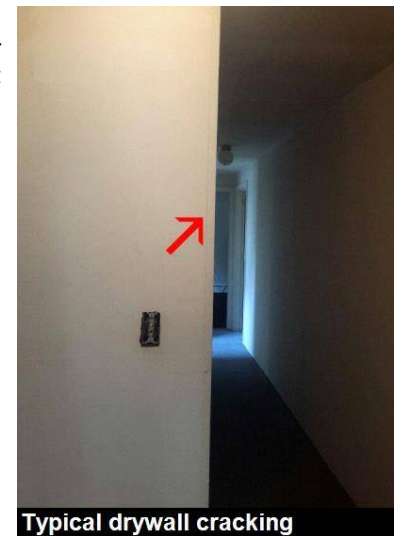
- ☒ ☐ ☐ General condition appears serviceable, There is some minor cracking in the sheetrock. Most likely this is due to slight settlement or shrinkage.

Typical drywall cracking

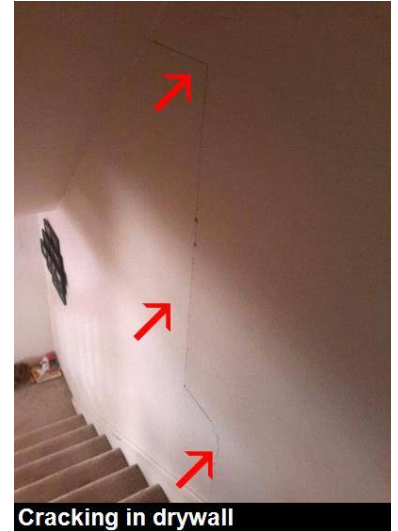
- ☐ ☒ ☐ There is some minor cracking in the sheetrock. Most likely this is due to slight settlement or shrinkage.

Cracking in drywall

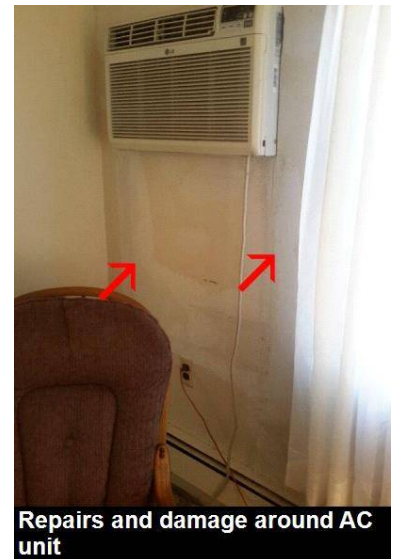
- ☐ ☒ ☐ Damage around window A C unit.

Repairs and damage around AC unit

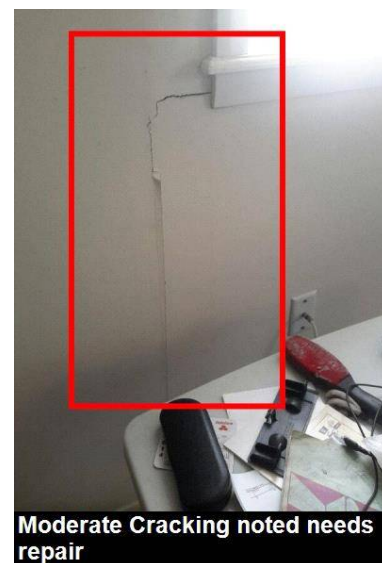
- OK MM RR  
☐ ☒ ☐ General condition appears serviceable, There is some minor cracking in the sheetrock. Most likely this is due to slight settlement or shrinkage.

Moderate Cracking noted needs repair

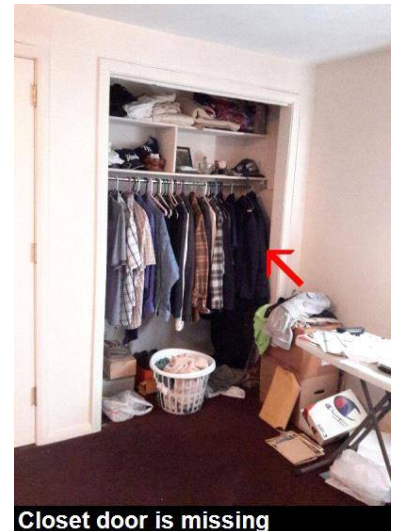
- ☐ ☒ ☐ General condition appears serviceable, The closet is not lighted, Closet door is missing.

Closet door is missing

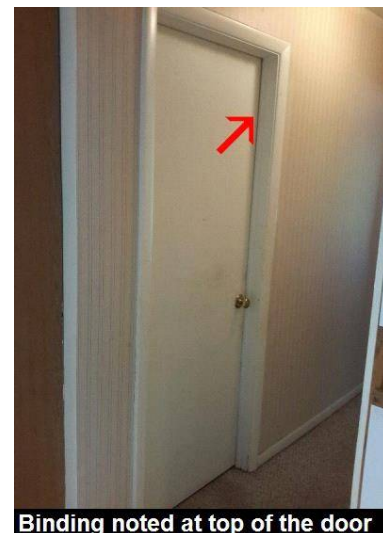
Hardware operational, Doorframes are not square. Some binding is noted.

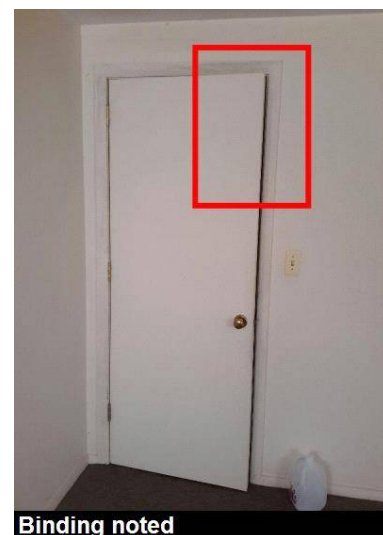
Doorframes are not square. Some binding is noted.

Binding noted

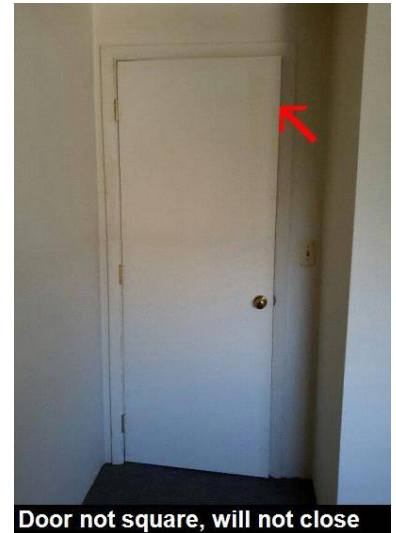
- ☐ ☒ ☐ Doorframes are not square. Some binding is noted.

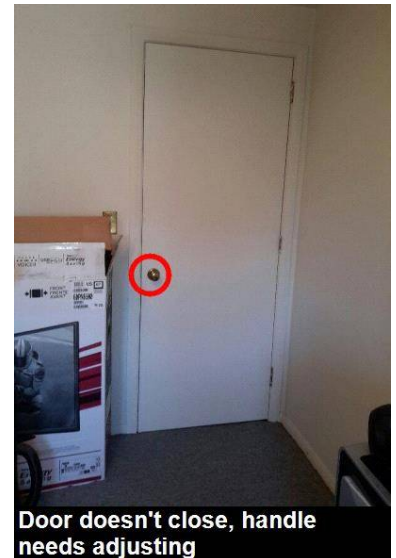
- OK MM RR  
☐ ☒ ☐ General condition appears serviceable, Hardware operational, Door hardware needs adjustment or repair, as the latch or strike plate needs adjustment so that the door will latch correctly.

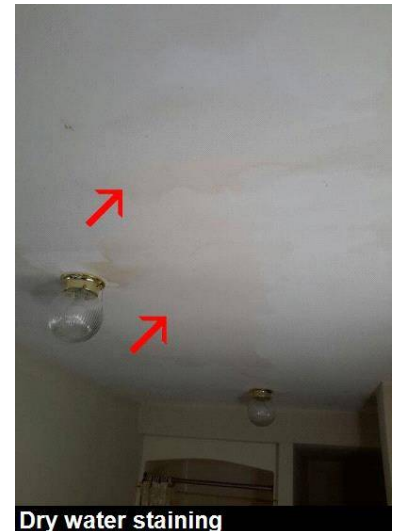
There is some minor cracking noted. Be sure to take note of any future movement. Most minor cracking is due to shrinkage of the construction materials. Previous Leak - There are signs (stains or repair) of a previous water leak in the ceiling in this room. It does not appear to be an active leak. Ceilings are in good condition with normal wear.

**Dry water staining**

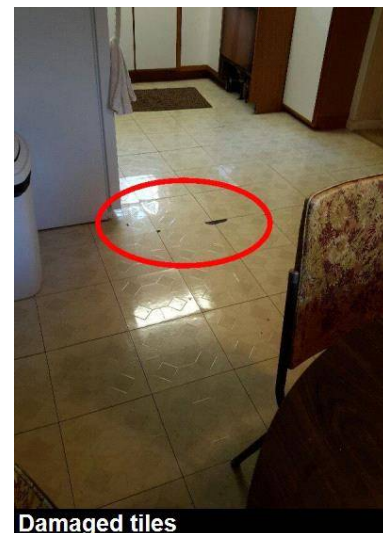
- ☐ ☒ ☐ General condition appears serviceable, The floor covering material is Vinyl planks/tiles. Fair - Material is worn, with some age. The floor in this room is in need of some attention or repair.

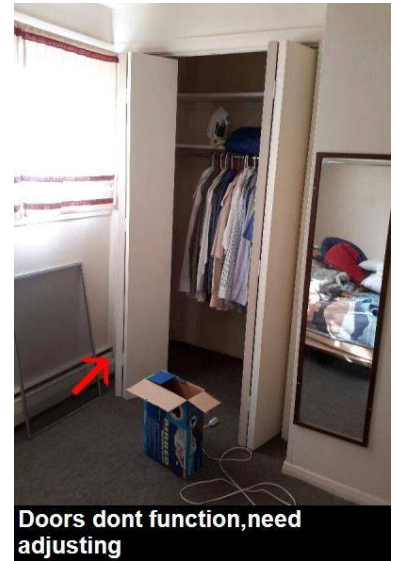
- ☐ ☐ ☒ Some portion of the closet door or interior fixtures needs adjustment or repair, as The closet is not lighted.

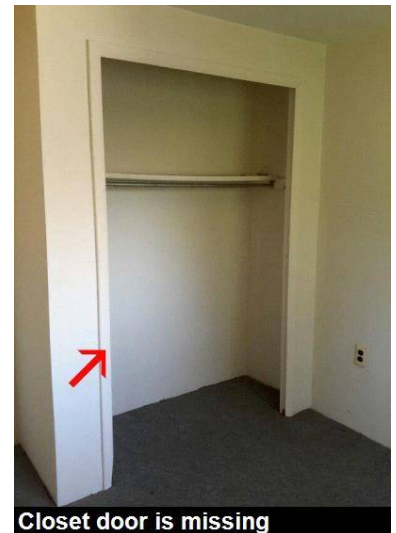
- OK MM RR  
☐ ☒ ☐ General condition appears serviceable, The closet is not lighted, Closet door is missing.

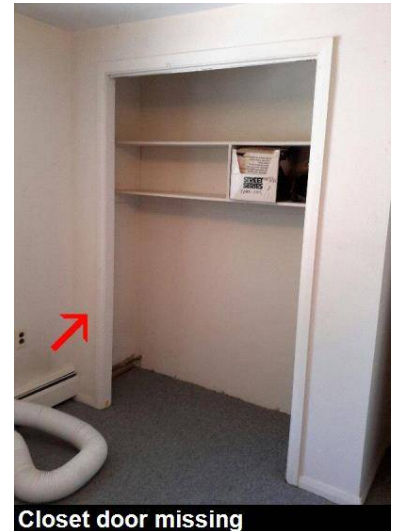
- ☐ ☒ ☐ General condition appears serviceable, The closet is not lighted, Closet door is missing.

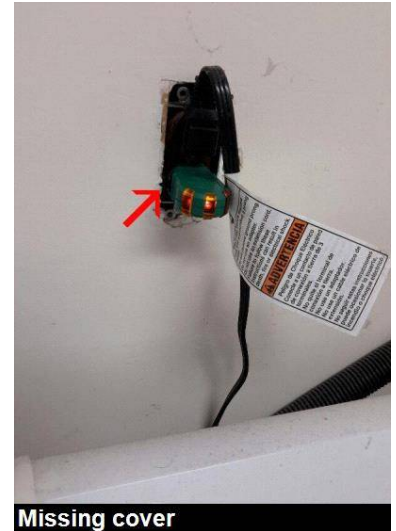
A representative sampling of switches and outlets was tested. As a whole, outlets and switches throughout the room are in serviceable condition. Missing or damaged cover plates viewed.

**Missing cover**
