**Visual Pro Home Inspections**  
6239 Eastmoor Road  
Bloomfield Hills MI 48301  
248-688-7918  
vincentcameron@VisualProHomeInspections.com

**Report: 8078**

## **Confidential Inspection Report**

**2450**  
**West Bloomfield, MI 48324**

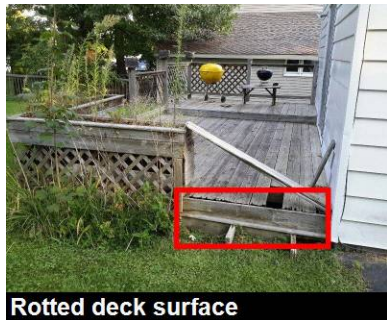
Wood, Deterioration noted to deck surface, Deck surface needs maintenance.

**Rotted deck surface**

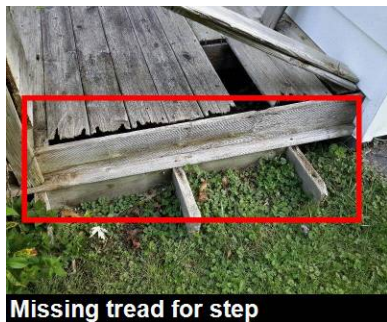
Wood, Rotted deck boards need to be replaced. Treads for step missing and need to be replaced.

**Missing tread for step**

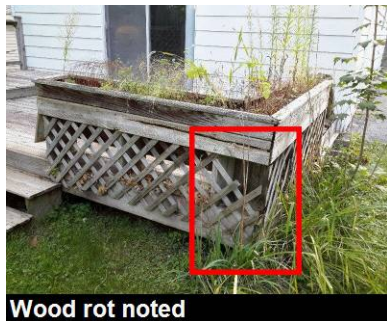
Wood, Deterioration noted to deck surface.

**Wood rot noted**

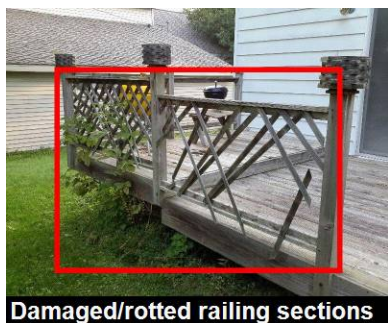
Wood, Handrails are loose/improper/missing. Correction is recommended.

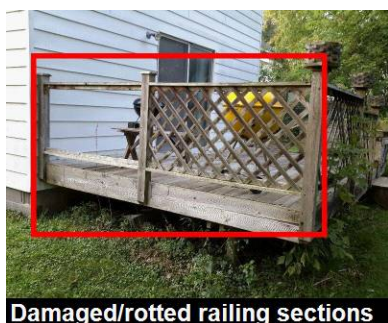
Wood, Handrails are loose/improper/missing. Correction is recommended.

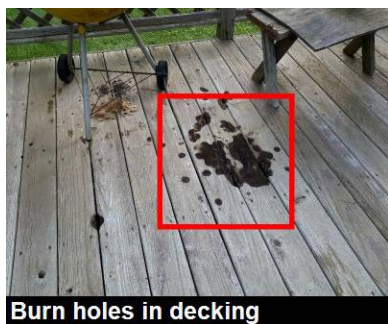
Wood, Deck surface burnt with burn holes on edges of decking. ....should be replaced.

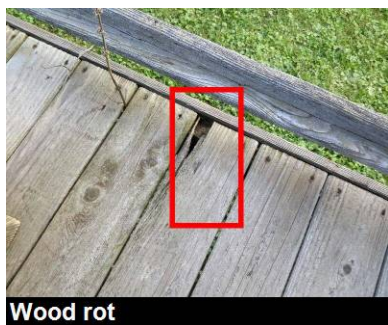
Wood, Deterioration noted to deck surface, Deck surface needs maintenance.

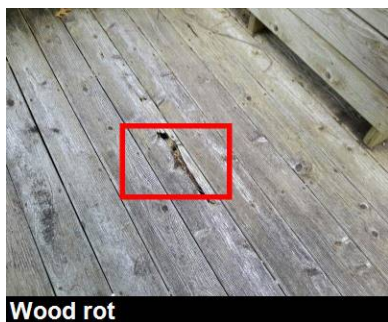
Wood, Deterioration noted to deck surface, Deck surface needs maintenance.

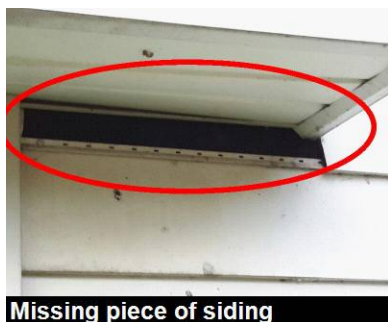
Walls are constructed with Aluminum siding. Missing top piece of siding.

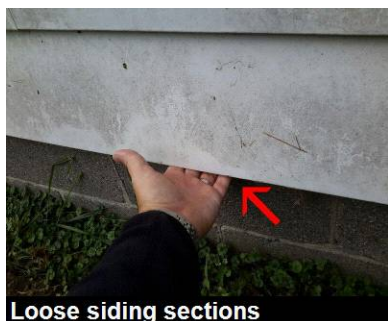
Walls are constructed with Aluminum siding. Bottom row of siding is loose.

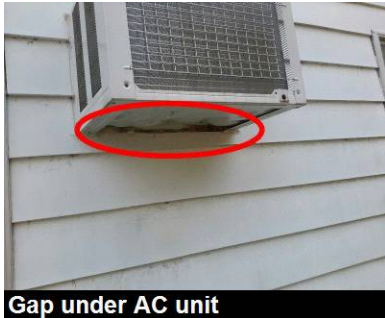
Gap under A C UNIT. Damaged areas of siding are seen, Walls are constructed with Aluminum siding.

**Gap under AC unit**

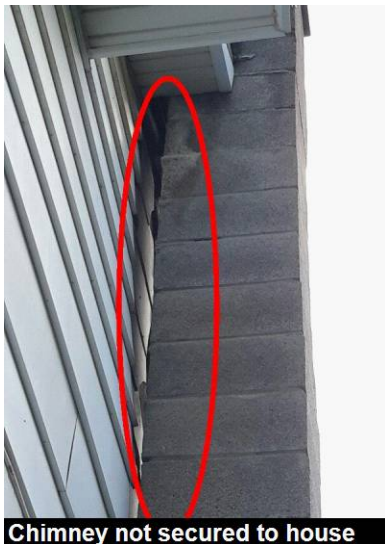
Chimney not secured to house. ....see chimney section.

**Chimney not secured to house**

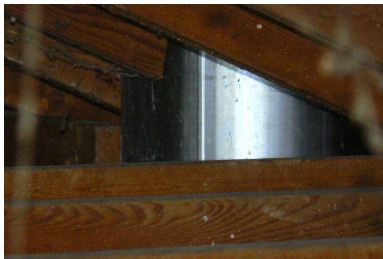
Daylight is showing though in the attic when not lit up with camera flash. You will want to repair the loose flashing on the roof around the chimney stack to prevent water entry into the attic.

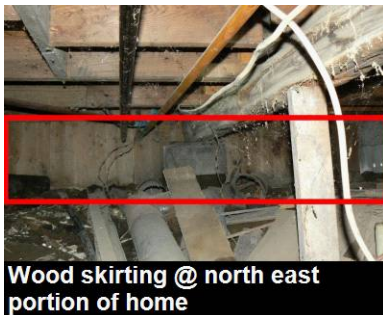
Post and beam construction is noted at north east section of home. Penetrations are noted in the skirting which allows rodent entry into the crawl. This is not a continuous footing in this section of the home.

**Wood skirting @ north east portion of home**

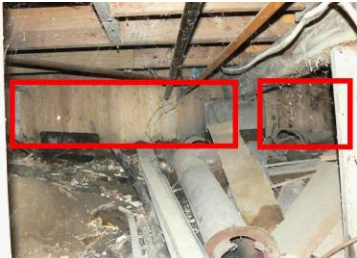
Post and beam construction is noted at north east section of home. Penetrations are noted in the skirting which allows rodent entry into the crawl. This is not a continuous footing in this section of the home.

**wood skirting noted**

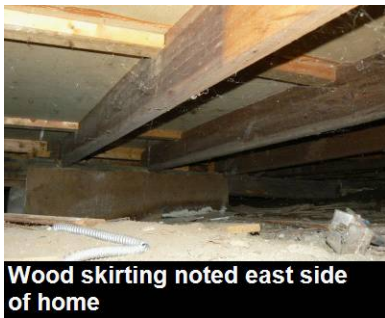
Post and beam construction is noted at north east section of home. Penetrations are noted in the skirting which allows rodent entry into the crawl. This is not a continuous footing in this section of the home.

**Wood skirting noted east side of home**

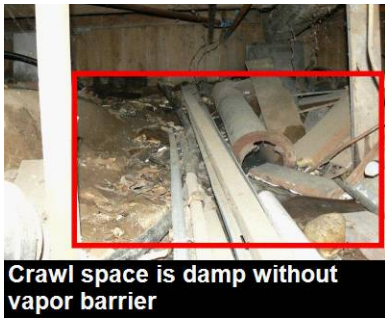
Yes - Higher than normal moisture levels were noted on the exposed areas of the interior crawlspace walls, and attention is needed to determine the cause and best cure. High moisture content in the exterior walls can lead to mildew and wood rot in high concentrations. The moisture content noted is high enough to cause either or both. There is evidence of water entry or damage in the crawlspace level. **Action Necessary** - At the time of the inspection there was water present. Immediate action is necessary to make repairs and to stop further damage. Estimates from reputable contractors are needed.

**Crawl space is damp without vapor barrier**

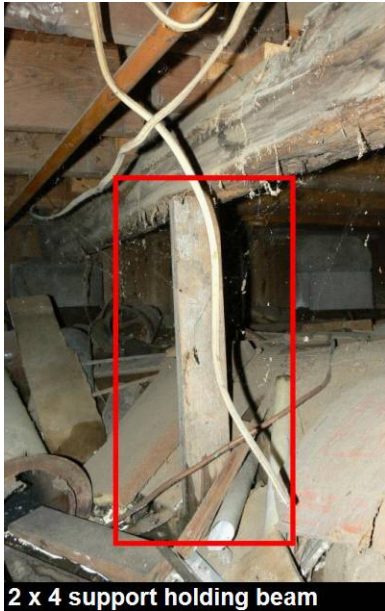
The main beam is in a condition that warrants replacement or repair. A 2 X 4 is being used to support a beam. This is not common practice. Earth to wood contact is noted along with moderated rot. The main beam is a single large dimension wood board.

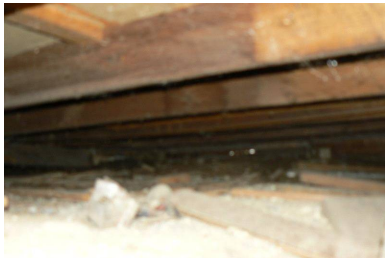
There is some ventilation in the crawlspace. However, additional ventilation is needed. Cross-ventilation in the crawlspace should have at least 1 square foot of net free vent space for every 1500 square feet of floor space when there is an approved vapor barrier installed. When there is no vapor barrier installed, there should be one square foot of vent space for every 150 square feet of crawlspace floor area. These vent openings should be located within 3 linear feet of the building corners.

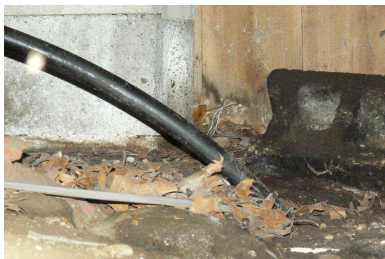
Soil, Earth-to-Wood contact is found, Remove wood debris and trash from the crawl space area.

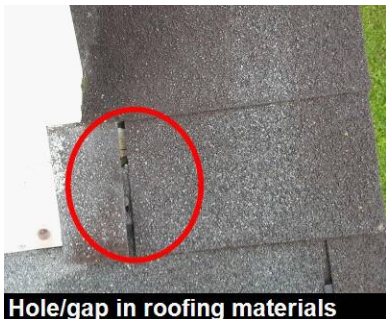
Damaged or missing Shingles noted. Repair/Replacement needed.

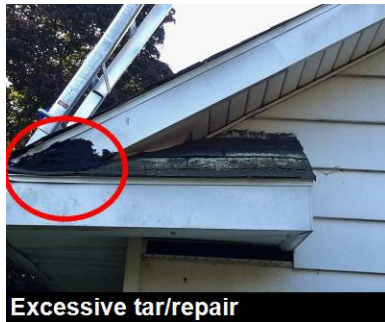
Damaged or missing Shingles noted. Repair/Replacement needed.

**Excessive tar/repair**

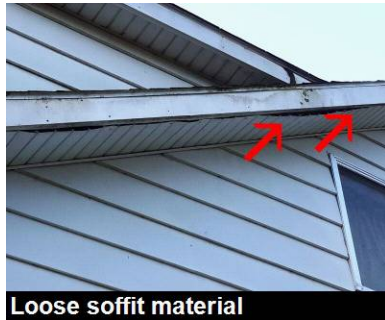
Soffits and overhang materials are aluminum. Loose soffit needs to be re secured.

**Loose soffit material**

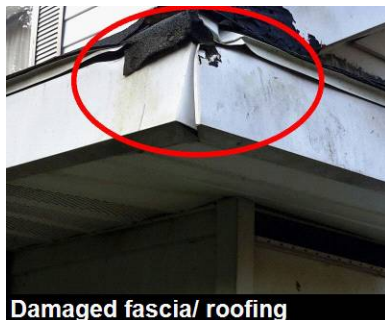
Soffits and overhang materials are aluminum. Damaged metal fascia pieces need to be repaired or replaced.

**Damaged fascia/ roofing**

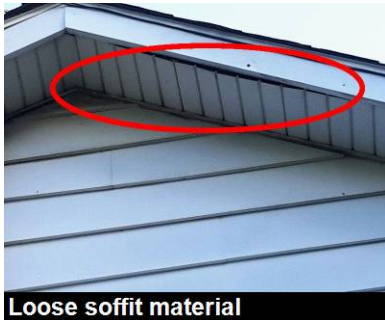
Soffits and overhang materials are aluminum. Loose soffit needs to be re secured.

**Loose soffit material**

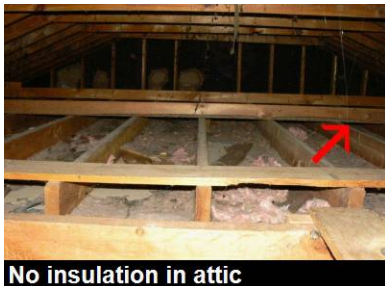
No insulation noted. Proper installation of insulation to increase the energy efficiency of the house is recommended. Recommend additional insulation in the attic area.

**No insulation in attic**

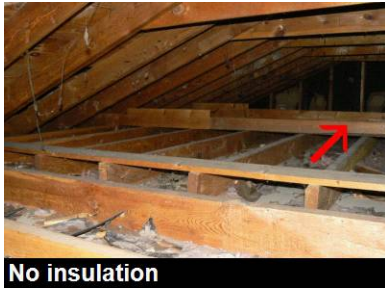
No insulation noted. Proper installation of insulation to increase the energy efficiency of the house is recommended. Recommend additional insulation in the attic area.

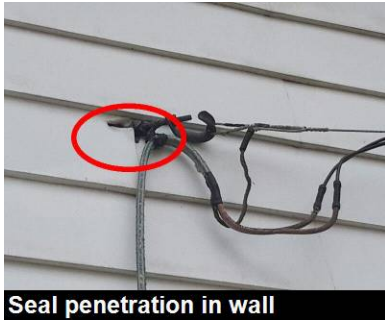
Damage/Defects noted: seal penetration in wall.

**Seal penetration in wall**

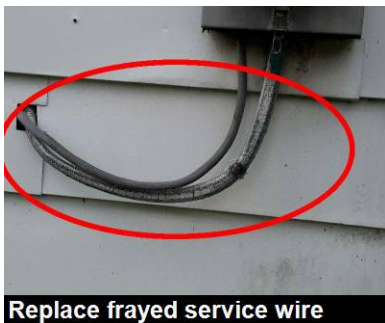
Electrical Service line is frayed and needs replacement from the line connection down to the meter.

Damage/Defects noted: frayed service wire needs to be replaced.

**Replace frayed service wire**

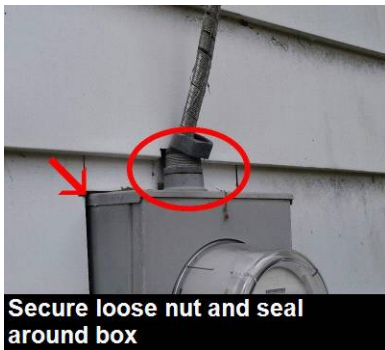
Re secure nut and seal around box.

**Secure loose nut and seal around box**

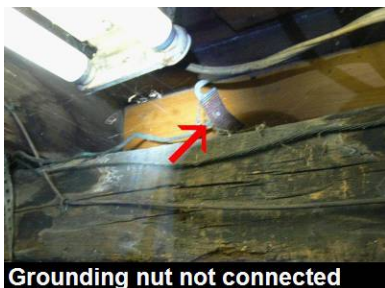
Grounding provided by connection to metallic water pipe. Not connected.

**Grounding nut not connected**

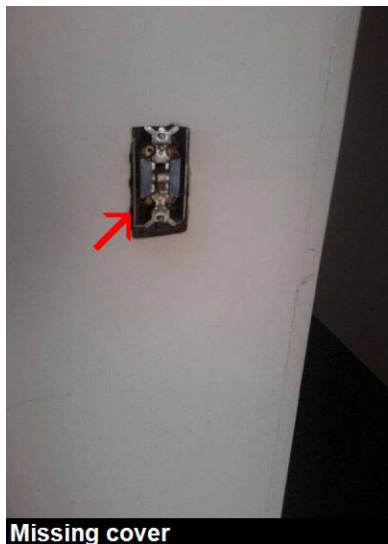
Switch cover is damaged, needs replacement.

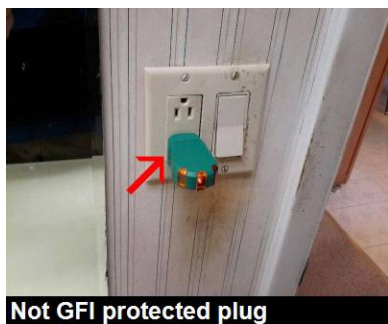
*Hall Bath:*

Ground Fault Circuit Interrupter (GFCI) outlets are recommended for installation at exterior, garage, bath rooms & kitchen outlets.

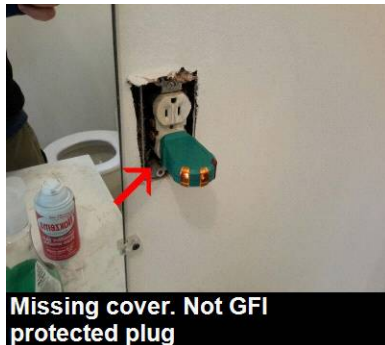
*Bath Between Bedrooms:*

Missing or damaged cover plates viewed, Ground Fault Circuit Interrupter (GFCI) outlets are recommended for

installation at exterior, garage, bath rooms & kitchen outlets.

Missing cover. Not GFI protected plug

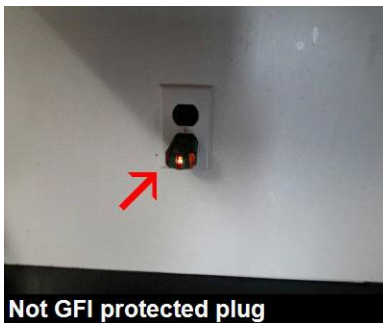
Ground Fault Circuit Interrupter (GFCI) outlets are recommended for installation at exterior, garage, bath rooms & kitchen outlets.

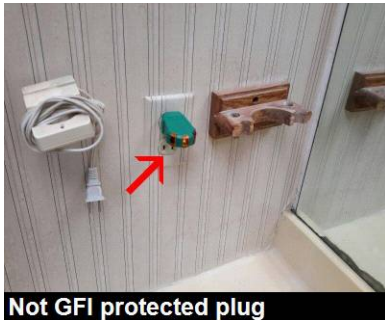
Ground Fault Circuit Interrupter (GFCI) outlets are recommended for installation at exterior, garage, bath rooms & kitchen outlets.

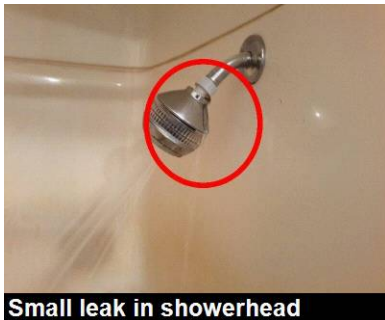
Bath Between Bedrooms:

The following problems were noted at the tub/shower drain: Minor leakage is noted at faucet handles.

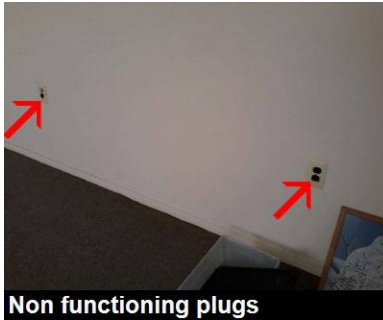
Some outlets did not function.

**Non functioning plugs**

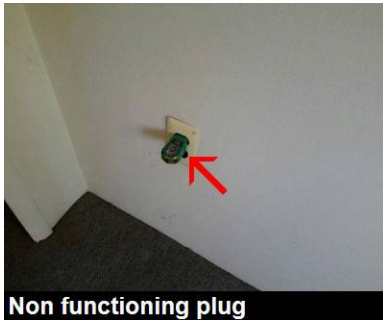
Bedroom #2:

Some outlets did not function.

**Non functioning plug**

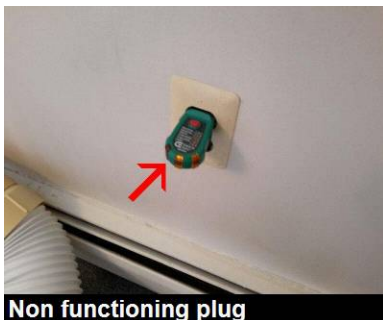
Bedroom #3:

Some outlets did not function.

**Non functioning plug**

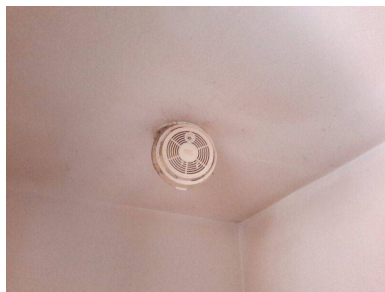
##### Entry / Foyer / Hall:

Repairs are needed - There is a nonworking smoke detector in this room. For safety considerations, it needs to be repaired or replaced immediately.

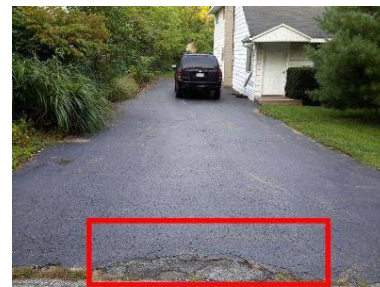
Asphalt, **Observations-** Cracks  
noted are typical, Surface  
raised/settled.

**Minor deterioration noted**☐ ☒ ☐

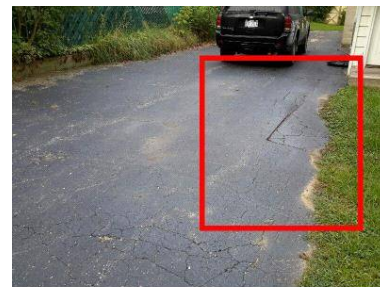
Asphalt, **Observations-** Cracks  
noted are typical, Surface  
raised/settled.

**Settled surface note**☐ ☒ ☐

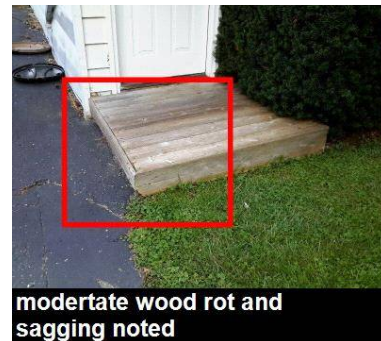
- ☐ ☒ ☐ Steps are constructed primarily of wood, Wood rot is noted, **Observations-** settlement or rotation is seen.

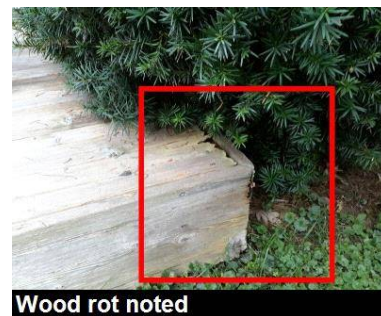
- OK MM RR  
☐ ☒ ☐ Steps are constructed primarily of wood, Wood rot is noted, **Observations-** settlement or rotation is seen.

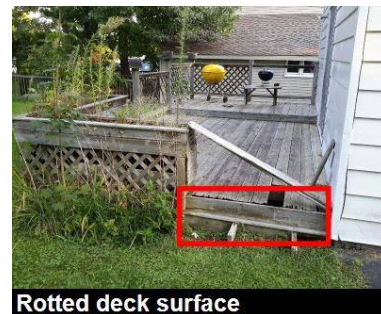
- ☐ ☐ ☒ Wood, Deterioration noted to deck surface, Deck surface needs maintenance.

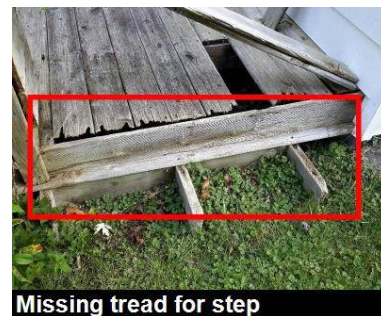
- ☐ ☐ ☒ Wood, Rotted deck boards need to be replaced. Treads for step missing and need to be replaced.

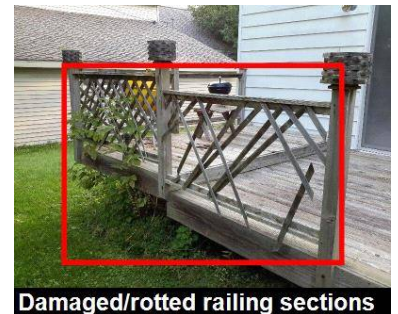
- ☐ ☐ ☒ Wood, Handrails are loose/improper/missing. Correction is recommended.

Damaged/rotted railing sections

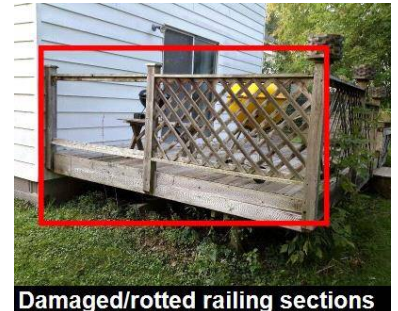
- ☐ ☐ ☒ Wood, Handrails are loose/improper/missing. Correction is recommended.

Damaged/rotted railing sections

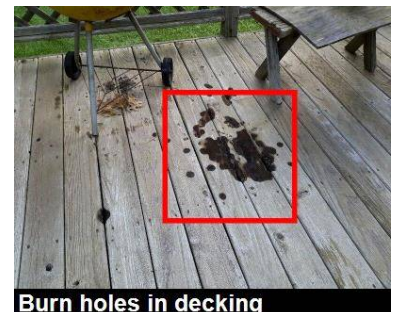
- ☐ ☐ ☒ Wood, Deck surface burnt with burn holes on edges of decking. ....should be replaced.

Burn holes in decking

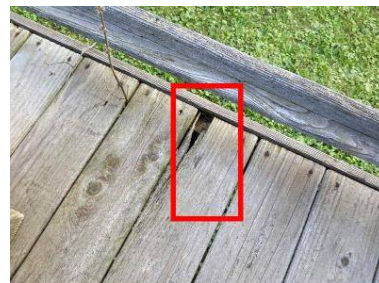
Wood, Deterioration noted to deck surface, Deck surface needs maintenance.

Wood rot

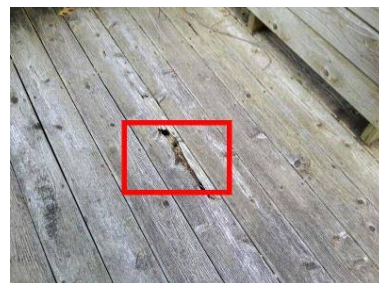
Wood, Deterioration noted to deck surface, Deck surface needs maintenance.

Wood rot

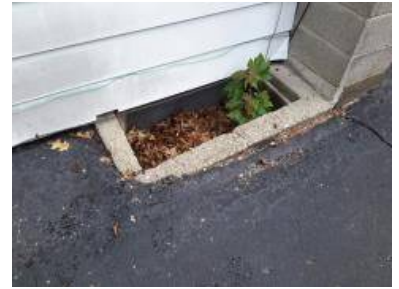
Window wells are uncovered. Make inquiry with seller about availability of covers.

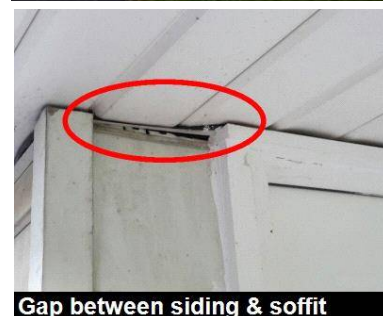
☐ ☒ ☐ Seal gap between siding and soffit.

Gap between siding & soffit

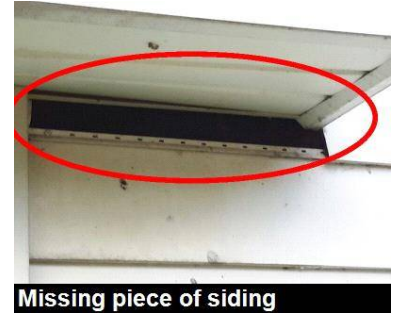
- ☐ ☐ ☒ Walls are constructed with Aluminum siding. Missing top piece of siding.

Missing piece of siding

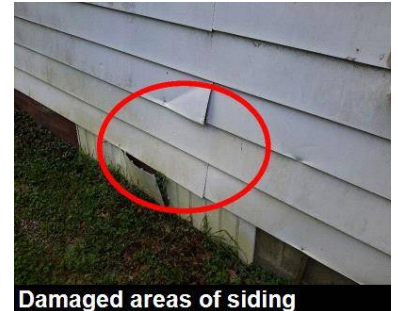
- OK MM RR  
☐ ☒ ☐ Walls are constructed with Aluminum siding. Damaged areas of siding are seen.

Damaged areas of siding

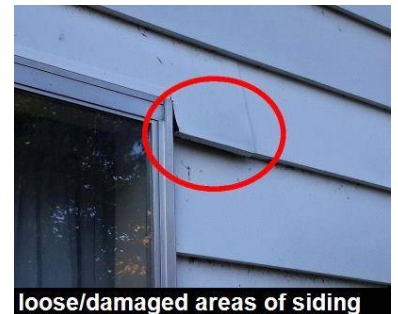
- ☐ ☒ ☐ Walls are constructed with Aluminum siding. Damaged areas of siding are seen.

loose/damaged areas of siding

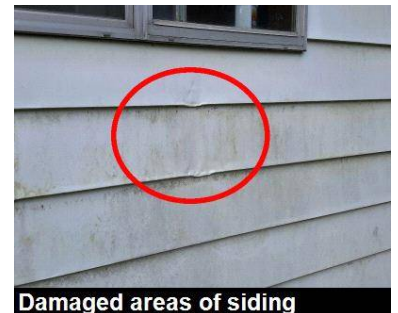
- ☐ ☒ ☐ Walls are constructed with Aluminum siding. Damaged areas of siding are seen.

Damaged areas of siding

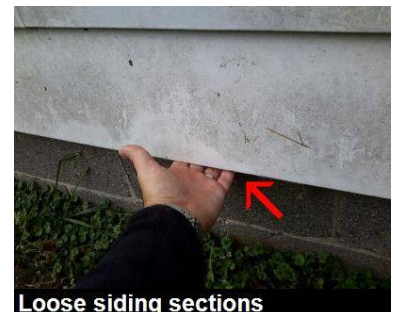
- ☐ ☐ ☒ Walls are constructed with Aluminum siding. Bottom row of siding is loose.

Loose siding sections

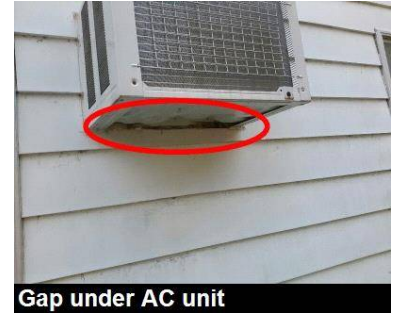
Gap under A C UNIT. Damaged areas of siding are seen, Walls are constructed with Aluminum siding.

Gap under AC unit

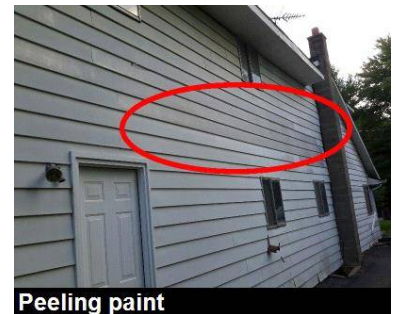
Paint peeling off siding. Walls are constructed with Aluminum siding. Damaged areas of siding are seen.

Peeling paint

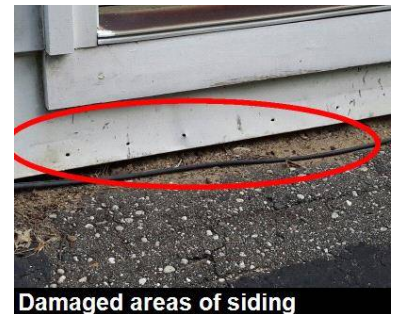
Walls are constructed with Aluminum siding. Damaged areas of siding are seen.

Damaged areas of siding

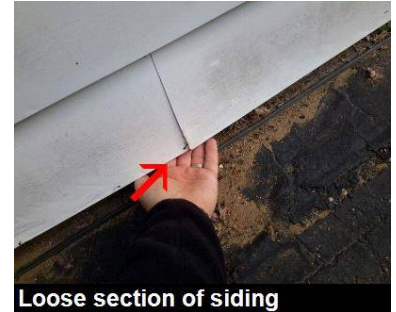
- ☐ ☒ ☐ Walls are constructed with Aluminum siding. Bottom row of siding is loose.

Loose section of siding

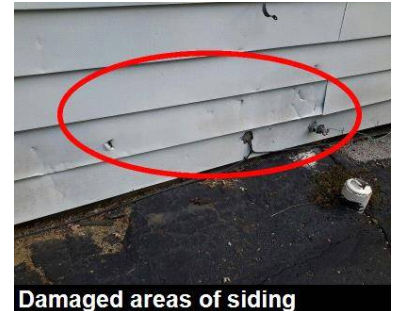
- OK MM RR  
☐ ☒ ☐ Walls are constructed with Aluminum siding. Damaged areas of siding are seen.

Damaged areas of siding

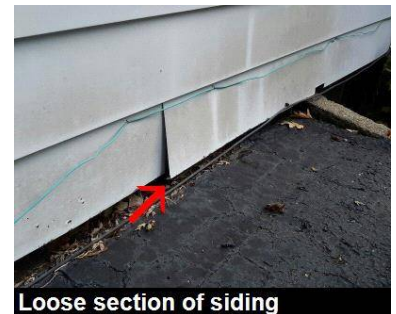
- ☐ ☒ ☐ Walls are constructed with Aluminum siding. Loose siding.

Loose section of siding

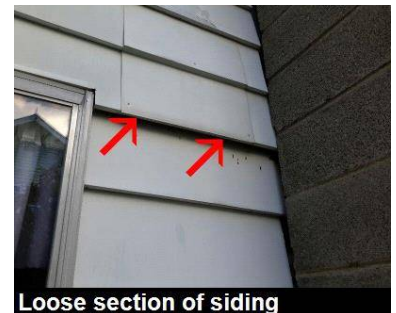
- ☐ ☒ ☐ Walls are constructed with Aluminum siding. Loose section of siding.

Loose section of siding

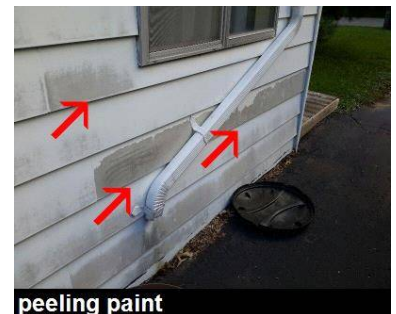
- ☐ ☒ ☐ Walls are constructed with Aluminum siding. Peeling paint.

peeling paint

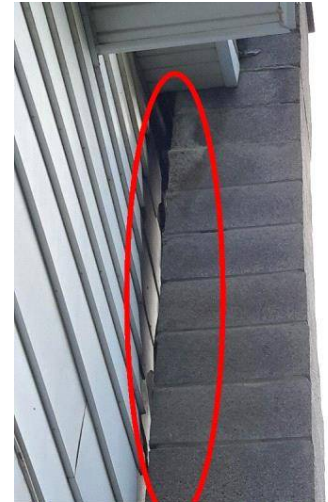
Chimney not secured to house. ....see chimney section.

Chimney not secured to house

- ☐ ☐ ☒ Chimney is constructed of concrete block materials. Flue stack separation is noted. Foundation that holds chimney has settled causing chimney to pull away from home. Most likely to continue to fall away creating a safety hazard. Best repair scenario would be to remove entire chimney and repair foundation below or install a new B-vent in its place with a new surround. Recommend repair and further inspection prior to use.

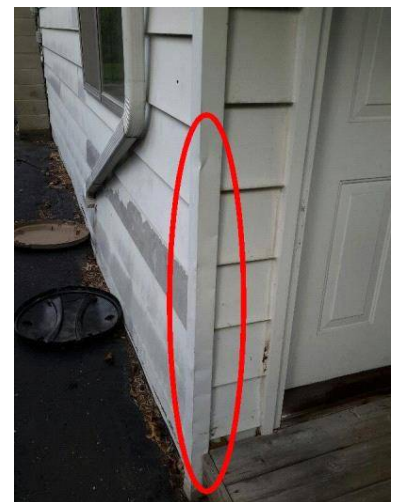
Metal materials. Damage noted.

Damaged to metal corner piece

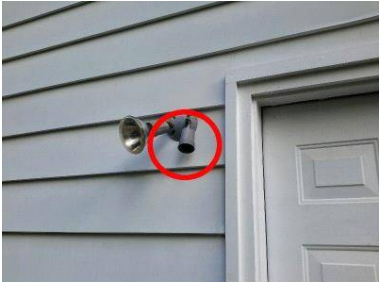
OK MM RR  
☐ ☒ ☐ Missing bulb.

Missing light bulb

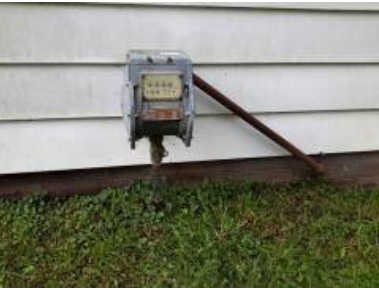
☐ ☐ ☒ Electrical Service line is frayed and needs replacement from the line connection down to the meter.

Electrical service line needs replacement

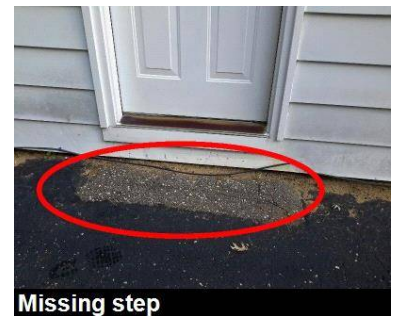
- ☐ ☒ ☐ Step missing coming out of door.

Missing step

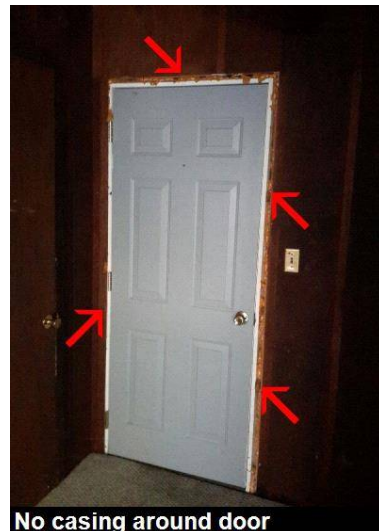
- ☐ ☐ ☒ Missing casing on inside. Door  
drags on carpet.

No casing around door

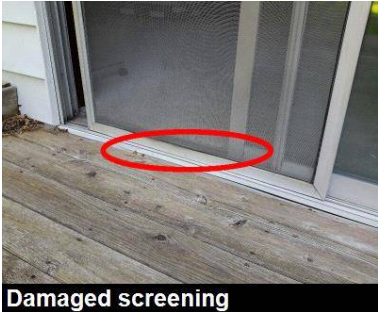
- ☐
- ☒
- ☐
- Minor damage to screen door.

Damaged screening

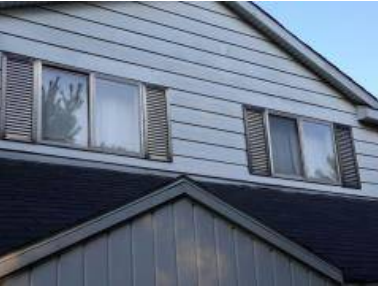
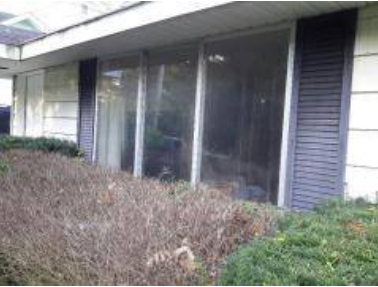
☐
- Satisfactory overall, considering age. Windows are flush with exterior walls. Re-caulk perimeter of all windows where gaps can be seen and where windows meet siding. This is a primary source of water leakage. Also, caulk the seams between adjacent windows where noted. A very narrow seam between adjacent metal frames sometimes allows rainwater to enter the exterior wall cavity. Caulk to be sure.  
Some screens are missing.
- ☒
- ☐
- ☐
- Satisfactory overall, considering age. Windows are flush with exterior walls. Re-caulk perimeter of all windows where gaps can be seen and where windows meet siding. This is a primary source of water leakage. Also, caulk the seams between adjacent windows where noted. A very narrow seam between adjacent metal frames sometimes allows rainwater to enter the exterior wall cavity. Caulk to be sure.  
Some screens are missing.

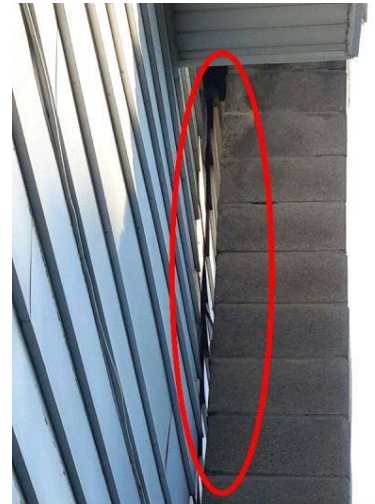
- ☐ ☐ ☒ Chimney is constructed of concrete block materials. Flue stack separation is noted. Foundation that holds chimney has settled causing chimney to pull away from home. Most likely to continue to fall away creating a safety hazard. Best repair scenario would be to remove entire chimney and repair foundation below or install a new B-vent in its place with a new surround. Recommend repair and further inspection prior to use.

- ☐ OK   
 ☐ MM   
 ☒ RR   
 Chimney is constructed of concrete block materials. Recommend repair and further inspection prior to use.

**Chimney separating from house**

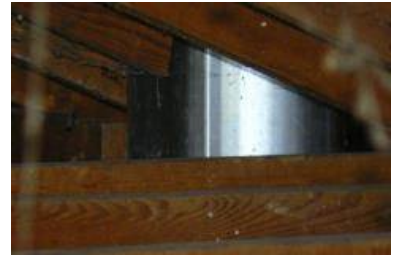
- OK MM RR  
☐ ☐ ☒ Daylight is showing though in the attic when not lit up with camera flash. You will want to repair the loose flashing on the roof around the chimney stack to prevent water entry into the attic.

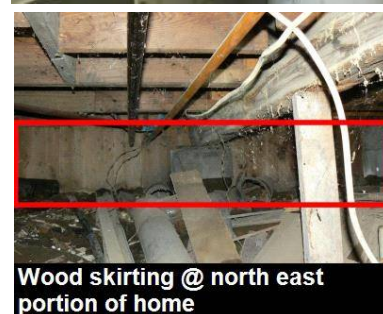
Post and beam construction is noted at north east section of home. Penetrations are noted in the skirting which allows rodent entry into the crawl. This is not a continuous footing in this section of the home.

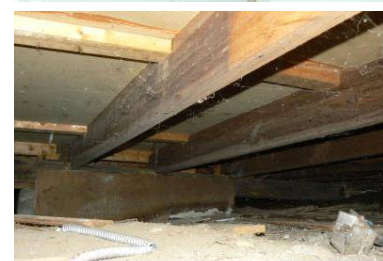
- ☐ ☐ ☒ Post and beam construction is noted at north east section of home. Penetrations are noted in the skirting which allows rodent entry into the crawl. This is not a continuous footing in this section of the home.

Wood skirting noted east side of home

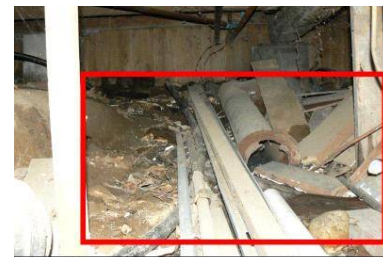
- ☐ ☐ ☒ Yes - Higher than normal moisture levels were noted on the exposed areas of the interior crawlspace walls, and attention is needed to determine the cause and best cure. High moisture content in the exterior walls can lead to mildew and wood rot in high concentrations. The moisture content noted is high enough to cause either or both. There is evidence of water entry or damage in the crawlspace level. **Action Necessary** - At the time of the inspection there was water present. Immediate action is necessary to make repairs and to stop further damage. Estimates from reputable contractors are needed.

Crawl space is damp without vapor barrier

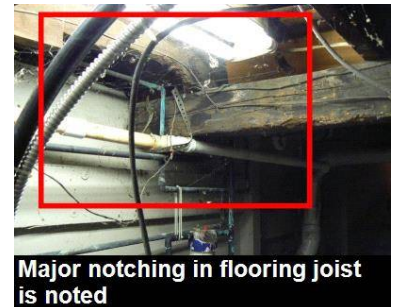
The main beam is a single large dimension wood board. Major notching is noted in some of the floor joists throughout the main floor system that will need repair.

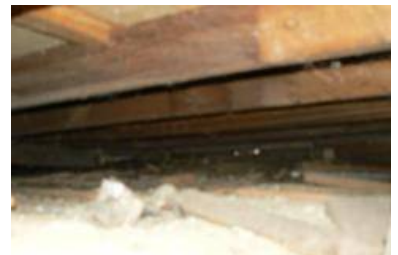
- ☐ ☐ ☒ There is some ventilation in the crawlspace. However, additional ventilation is needed. Cross-ventilation in the crawlspace should have at least 1 square foot of net free vent space for every 1500 square feet of floor space when there is an approved vapor barrier installed. When there is no vapor barrier installed, there should be one square foot of vent space for every 150 square feet of crawlspace floor area. These vent openings should be located within 3 linear feet of the building corners.

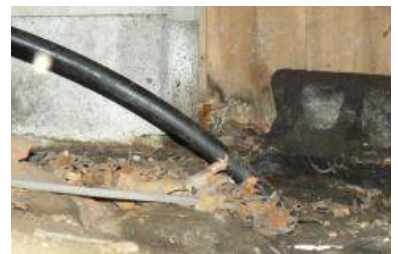
- ☐ ☐ ☒ Soil, Earth-to-Wood contact is found, Remove wood debris and trash from the crawl space area.

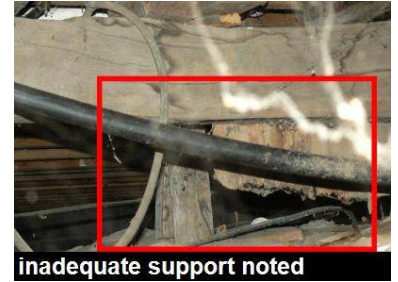
The post installed is solid wood. Some piers and posts are damaged and unsecured. There is soil to wood contact. This allows a direct path for insects and should be eliminated. The piers as installed appear to need some repair. No engineering analysis was completed. However, a simple visual inspection draws one's attention to inadequacy. Repairs are needed.

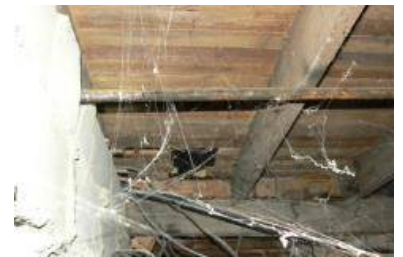
☐ ☐ ☒ No under floor insulation exists.

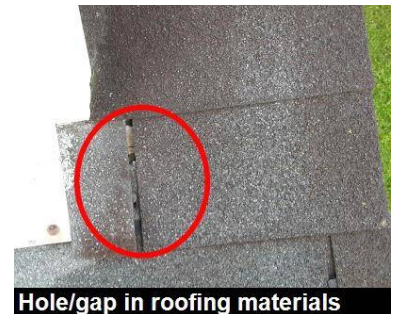
- OK MM RR  
☐ ☐ ☒ Damaged or missing Shingles noted. Repair/Replacement needed.

Hole/gap in roofing materials

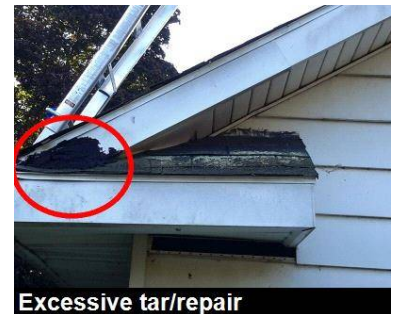
- ☐ ☐ ☒ Damaged or missing Shingles noted. Repair/Replacement needed.

Excessive tar/repair

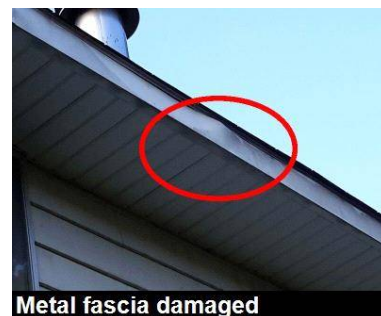
☐ ☒ ☐ Soffits and overhang materials are aluminum. Fascia damaged.

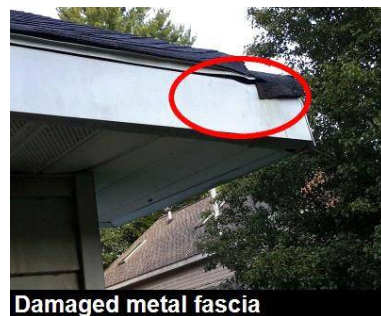
**Damaged fascia/ roofing**☐ ☒ ☐ Soffits and overhang materials are aluminum. Damaged metal fascia pieces need to be repaired or replaced.

**Damaged metal fascia**

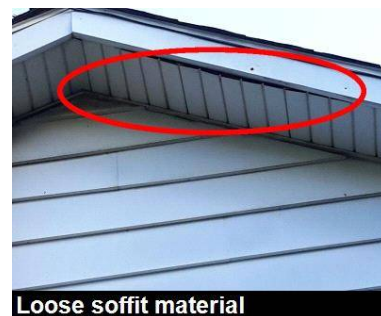
- OK MM RR  
☐ ☐ ☒ Soffits and overhang materials are aluminum. Loose soffit needs to be re secured.

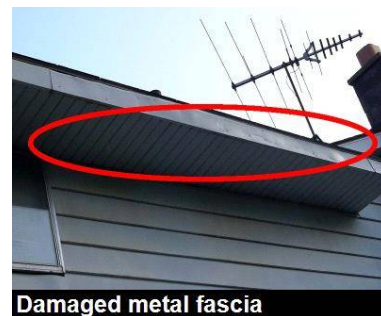
- ☐ ☒ ☐ Soffits and overhang materials are aluminum. Damaged and loose metal fascia needs to be repaired or replaced.

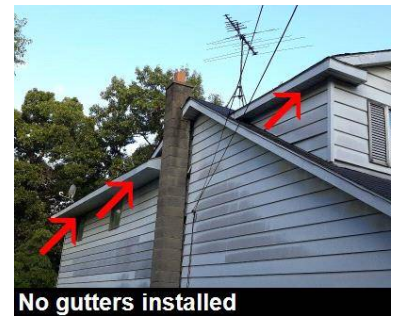
- OK MM RR  
☐ ☒ ☐ Consider installing gutters and downspouts to help with site drainage.

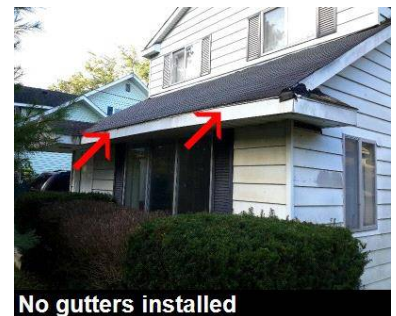
- ☐ ☒ ☐ Consider installing gutters and downspouts to help with site drainage.

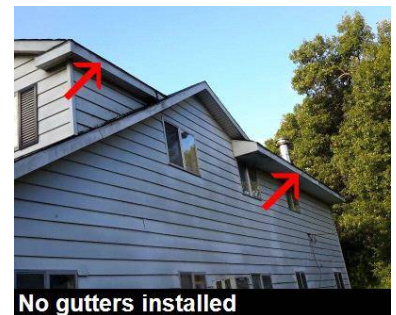
- ☐ ☒ ☐ Consider installing gutters and downspouts to help with site drainage.

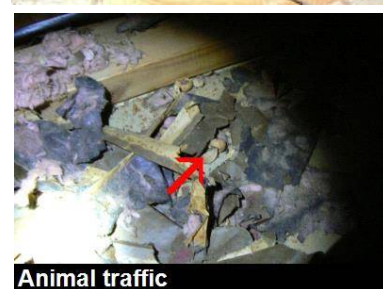
☐ ☒ ☐ Evidence of animals in attic.

**Animal traffic**

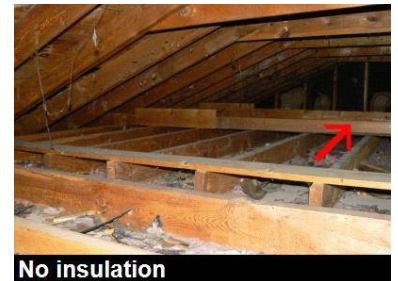
- OK MM RR  
☐ ☐ ☒ No insulation noted. Proper installation of insulation to increase the energy efficiency of the house is recommended. Recommend additional insulation in the attic area.

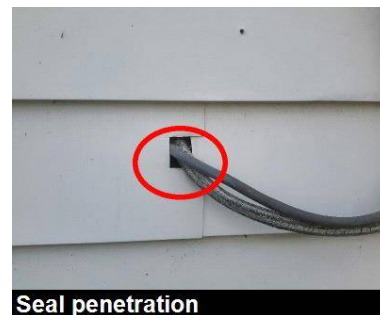
Damage/Defects noted: seal

Seal penetration

Replace frayed line, seal penetrations

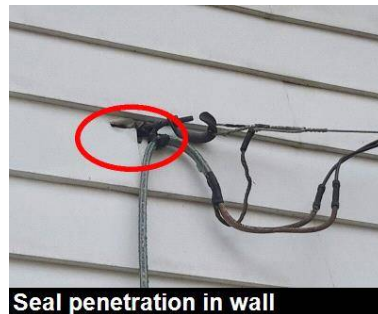
- ☐ ☐ ☒ Damage/Defects noted: seal penetration in wall.

Seal penetration in wall

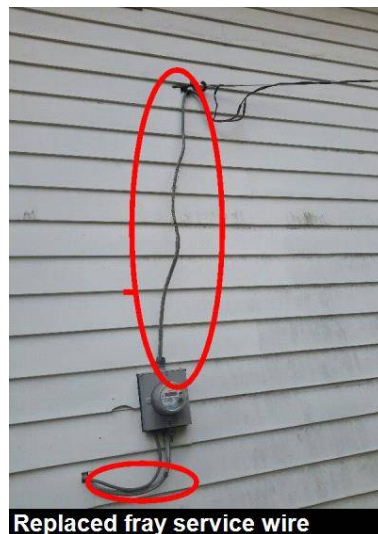
- OK MM RR  
☐ ☐ ☒ Damage/Defects noted: frayed service wire needs to be replaced.

Replaced fray service wire

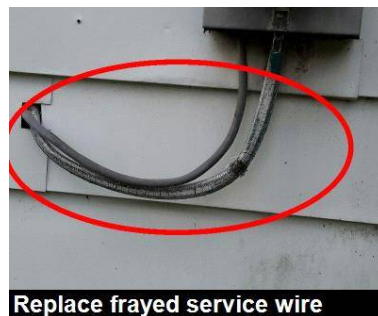
- ☐ ☐ ☒ Damage/Defects noted: frayed service wire needs to be replaced.

Replace frayed service wire

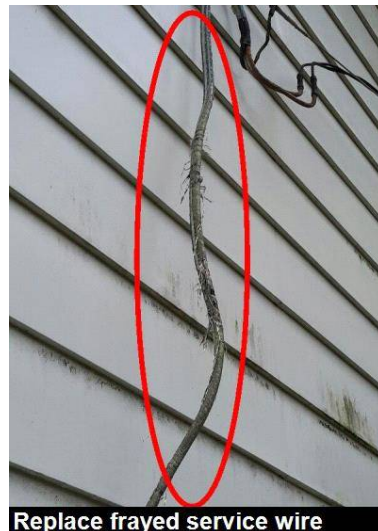
- ☐ ☐ ☒ Damage/Defects noted: frayed service wire needs to be replaced.

Replace frayed service wire

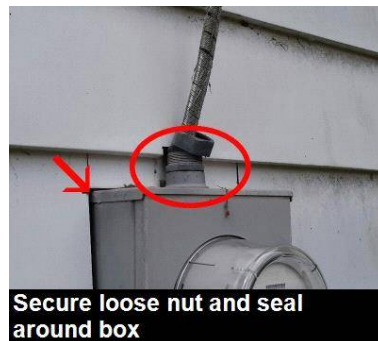
- OK MM RR  
☐ ☐ ☒ Re secure nut and seal around box.

Secure loose nut and seal around box

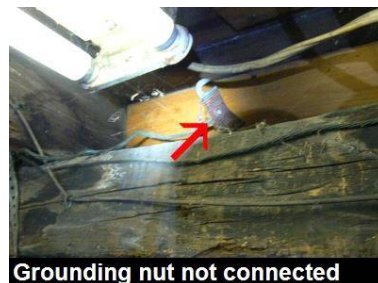
- ☐ ☐ ☒ Grounding provided by connection to metallic water pipe. Not connected.

Grounding nut not connected

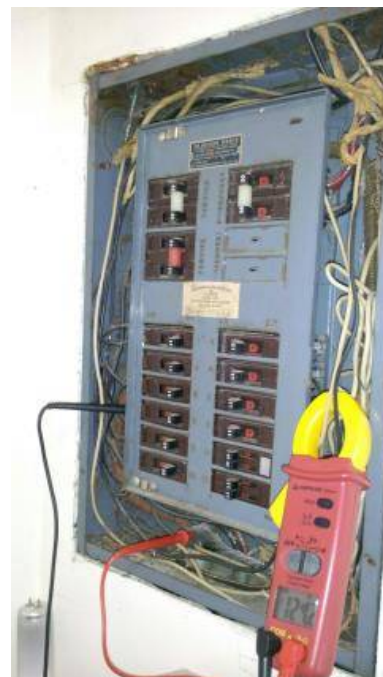
Circuit and wire sizing correct so far as visible, Grounding system is present, Electrical system appears outdated by today's standards. Upgrade should be considered.

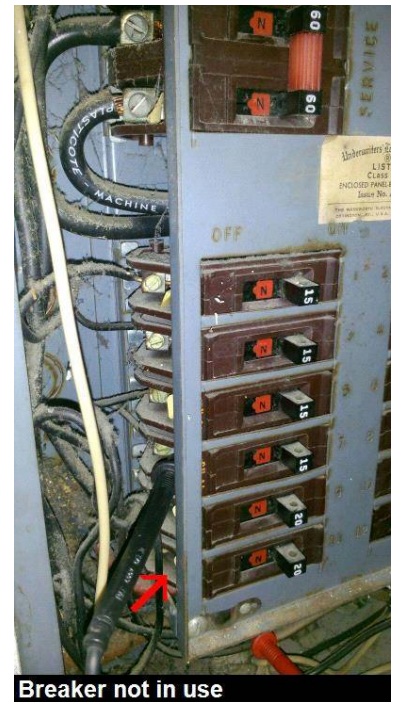
OK MM RR  
☐ ☒ ☐ Some breakers not in use.

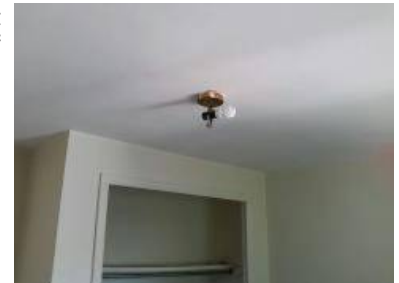
Master Bedroom:	A representative sampling of switches was tested. As a whole, switches throughout the room are in serviceable condition.
Bedroom #2:	<p>The ceiling light installed in this room did not function using the wall switch. I did not determine if the switch is bad or if the light bulb is bad.</p>

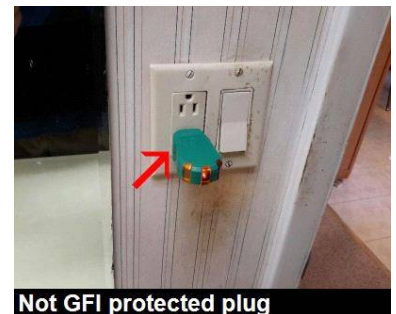
- ☐ ☐ ☒ Ground Fault Circuit Interrupter (GFCI) outlets are recommended for installation at exterior, garage, bath rooms & kitchen outlets.

Not GFI protected plug

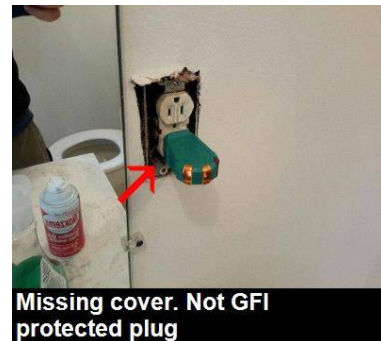
- ☐ ☐ ☒ Missing or damaged cover plates viewed, Ground Fault Circuit Interrupter (GFCI) outlets are recommended for installation at exterior, garage, bath rooms & kitchen outlets.

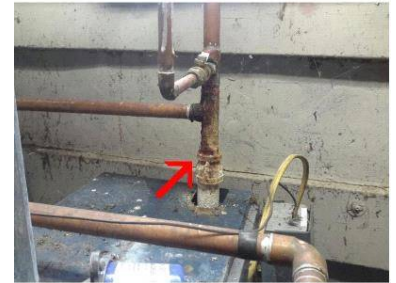
Corrosion on main pipe.

Corrosion on pipe

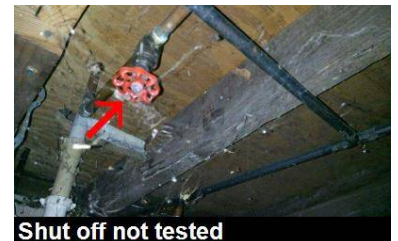
Shut-off valves are provided at water lines serving fixtures. Shut-off valves are not tested for operation during the inspection. Be forewarned that most cutoff valves are not operated regularly and as such they are prone to leak when operated. They should only be used to shut off the water in the event of a leak that could damage surrounding materials. Minor corrosion is noted.

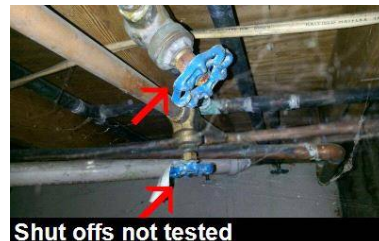
- ☐ ☒ ☐ Shut-off valves are provided at water lines serving fixtures. Shut-off valves are not tested for operation during the inspection. Be forewarned that most cutoff valves are not operated regularly and as such they are prone to leak when operated. They should only be used to shut off the water in the event of a leak that could damage surrounding materials. Minor corrosion is noted.

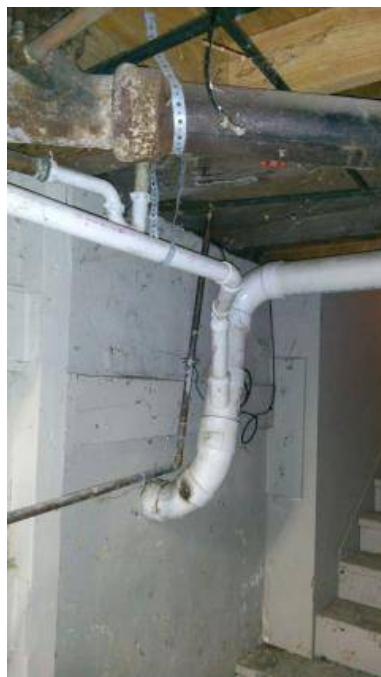
Plastic. Plumbing vents appear serviceable.

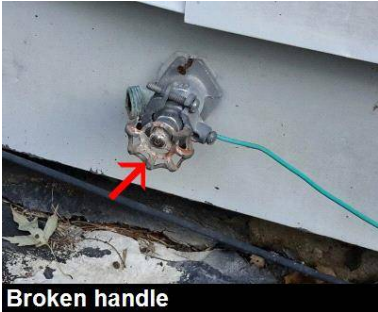
- ☐ ☒ ☐
- Some inoperative, Broken handle noted.

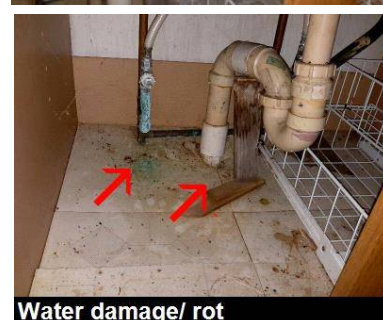
Cabinet is showing signs of water damage.

**Water damage/ rot**

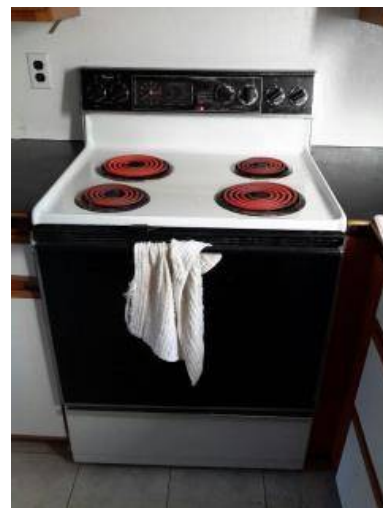
Electric, Free-standing, Appears serviceable, Stove has not been secured as required by manufacturer's installation instructions. A tip-over hazard exists for small children. Stove should be properly secured right-away.

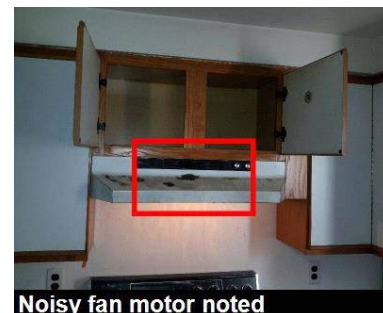
**Ventilation:***Type & Condition:*☐ ☒ ☐ Internal, Fan/Hood operational, Exhaust fan is noisy.

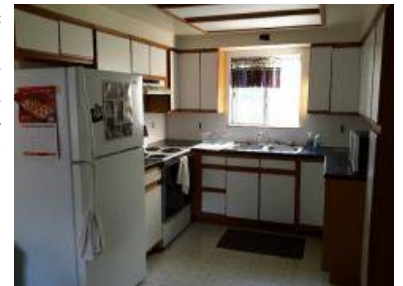
Counters are Formica (plastic laminate) with serviceable appearance, moderate to heavy wear, Caulking is needed in the vicinity of the sink, Cabinets appear serviceable with moderate to heavy wear.

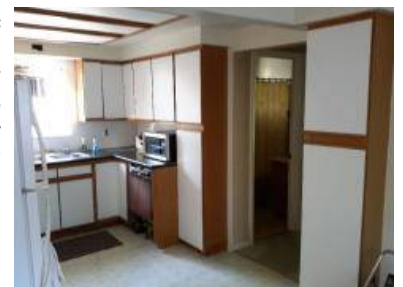
Counters are Formica (plastic laminate) with serviceable appearance, moderate to heavy wear, Caulking is needed in the vicinity of the sink, Cabinets appear serviceable with moderate to heavy wear.

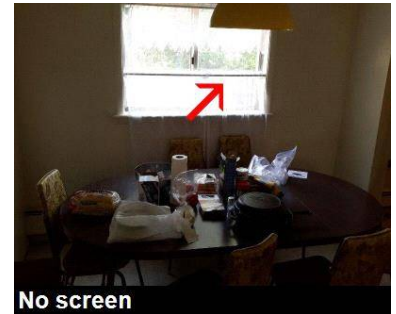
- ☐ ☒ ☐ At least one window or associated hardware in this room needs repair. There is no screen in place at the window.

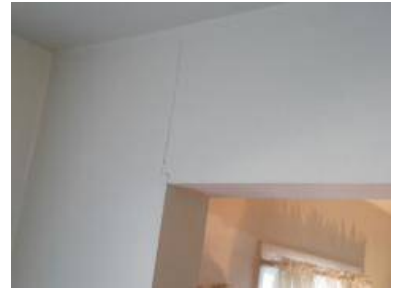
- OK MM RR  
☒ ☐ ☐ General condition appears serviceable, There is some minor cracking in the sheetrock. Most likely this is due to slight settlement or shrinkage.

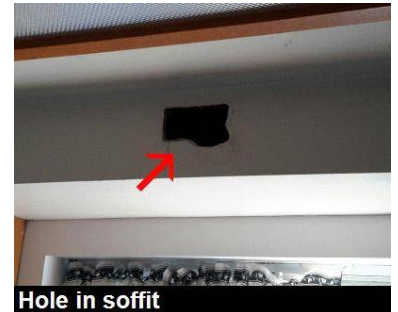
- ☐ ☒ ☐ Hole in soffit.

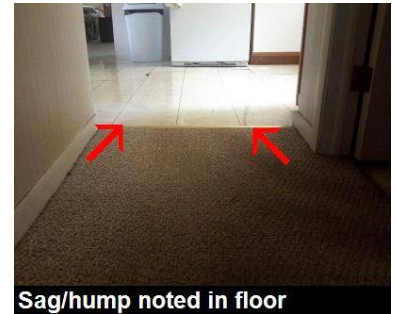
- ☐ ☒ ☐ There is some sagging in the floor that would be considered typical, does not appear to be of structural significance.

Sag/hump noted in floor

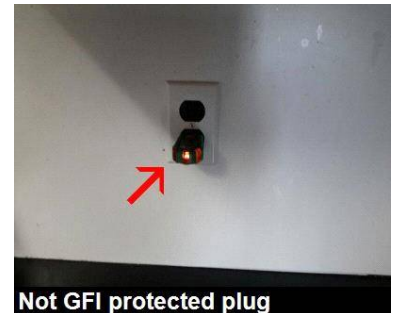
Not GFI protected plug

- OK MM RR  
☐ ☐ ☒ Ground Fault Circuit Interrupter (GFCI) outlets are recommended for installation at exterior, garage, bath rooms & kitchen outlets.

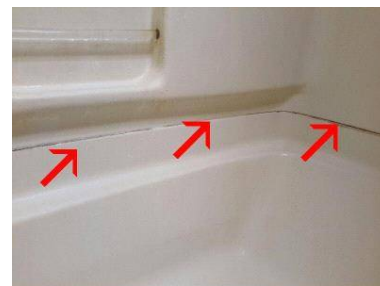
caulk/seal seams in tub areas

Caulk and seal all tub and shower areas as a precaution.

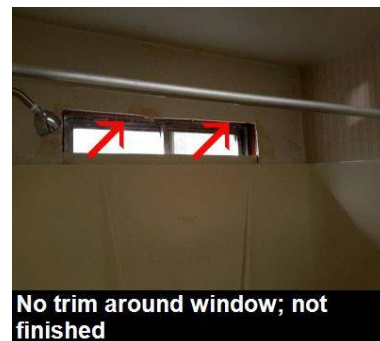
Unfinished wall..... no trim around window. Needs repair.

No trim around window; not finished

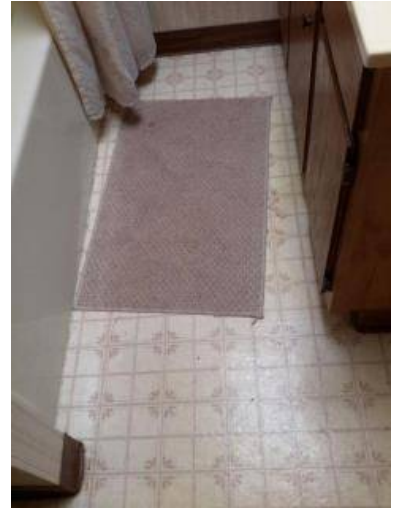
The floor covering material is Vinyl planks/tiles Fair  
- Material is worn, with some age.

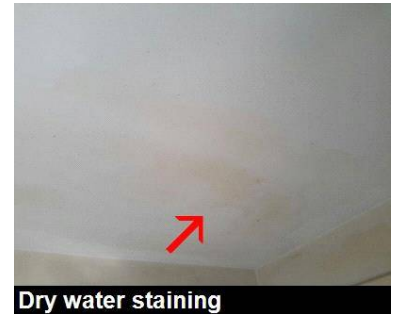
Previous Leak - There are signs (stains or repair) of a previous water leak in the ceiling in this room. It does not appear to be an active leak.

Dry water staining

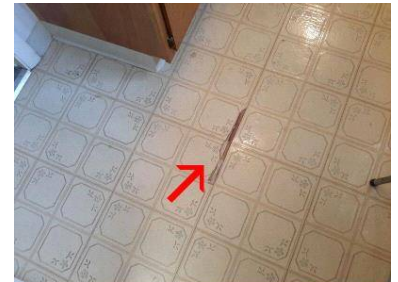
The floor covering material is Vinyl planks/tiles The floor in this room is in need of some attention or repair.

Damaged floor tile

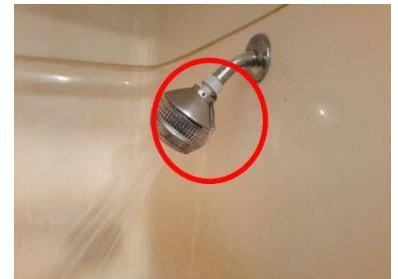
Bath Between Bedrooms:

☐ ☐ ☒ The following problems were noted at the tub/shower drain: Minor leakage is noted at faucet handles.

Small leak in showerhead

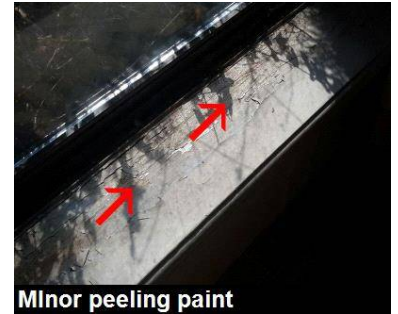
- OK MM RR  
☒ ☐ ☐ General condition appears serviceable, Minor peeling paint on sill.

Minor peeling paint

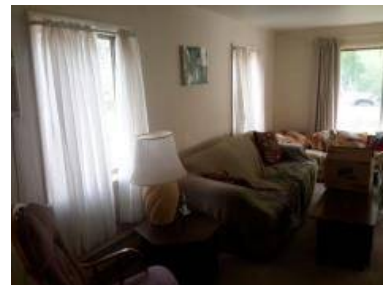
☒ ☐ ☐ General condition appears serviceable, There is some minor cracking in the sheetrock. Most likely this is due to slight settlement or shrinkage.

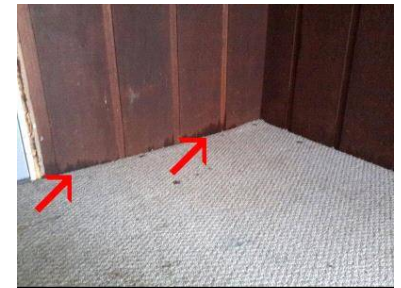
- OK MM RR  
☐ ☒ ☐ Water stains at bottom of wall.

Water staining at bottom of wall
