**Visual Pro Home Inspections**  
6239 Eastmoor Road  
Bloomfield Hills MI 48301  
248-688-7918  
vincentcameron@VisualProHomeInspections.com

**Report: 8078**

## **Confidential Inspection Report**

**2450**  
**West Bloomfield, MI 48324**

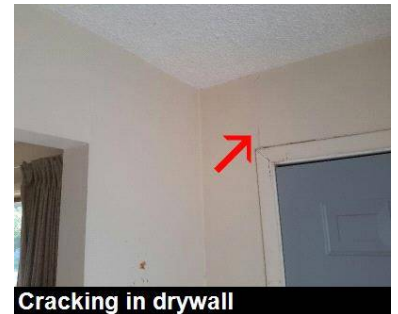
- OK MM RR  
☒ ☐ ☐ General condition appears serviceable, There is some minor cracking in the sheetrock. Most likely this is due to slight settlement or shrinkage.

Cracking in drywall

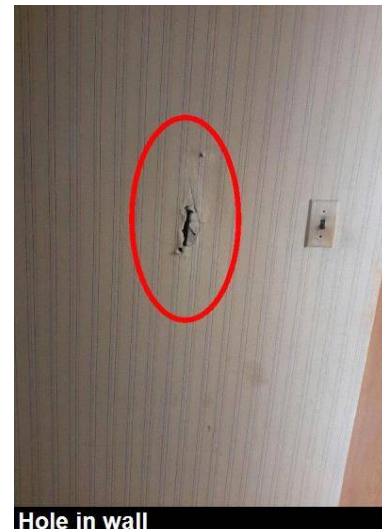
☐ ☒ ☐ Hole in wall.

Hole in wall

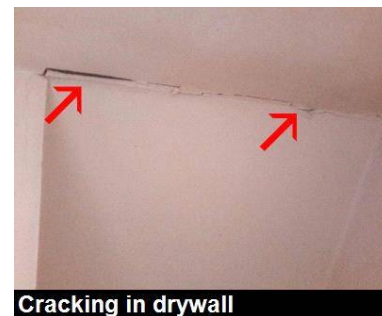
General condition appears serviceable, There is some minor cracking noted. Be sure to take note of any future movement. Most minor cracking is due to shrinkage of the construction materials.

Cracking in drywall

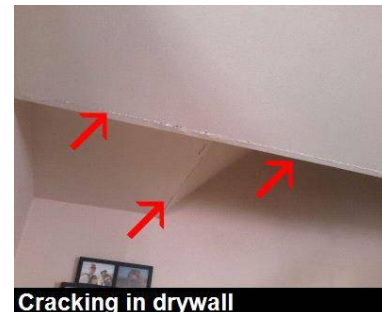
- ☐ ☒ ☐ General condition appears serviceable, There is some minor cracking noted. Be sure to take note of any future movement. Most minor cracking is due to shrinkage of the construction materials.

Cracking in drywall

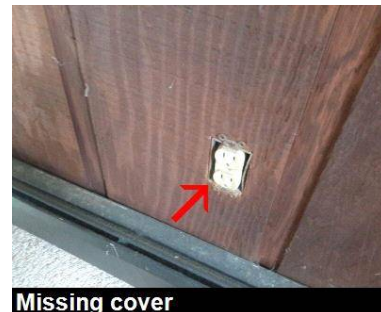
☐ ☒ ☐ Missing or damaged cover plates viewed.

**Missing cover**

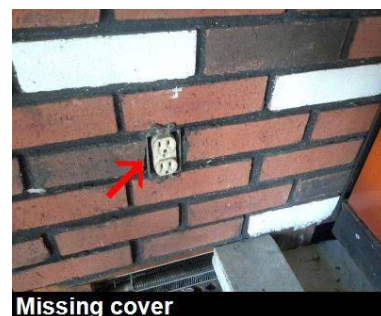
OK MM RR  
☐ ☒ ☐ Missing or damaged cover plates viewed.

**Missing cover***Ductwork / Distribution:*

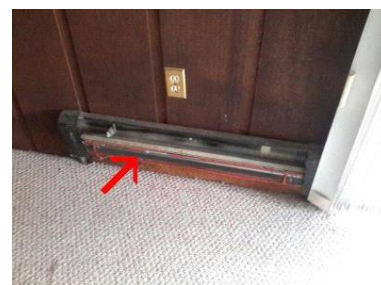
☐ ☒ ☐ Missing cover.

**Missing cover**

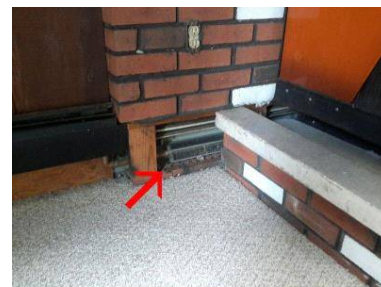
☐ ☒ ☐ Missing cover.

**Missing cover***Fireplaces / Solid Fuel Heating:*

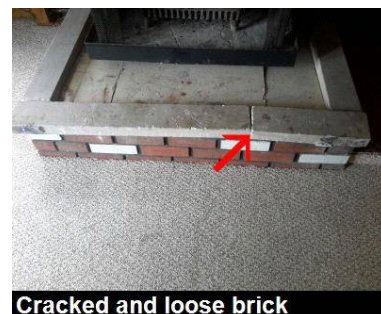
☐ ☒ ☐ Cracked and loose brick.

**Cracked and loose brick**

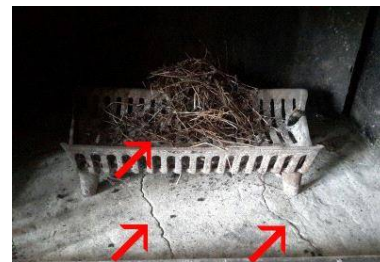
OK MM RR  
☐ ☒ ☐ Cracks in cement. ....nest material  
in fireplace.

Cracks in cement; nesting  
material inside

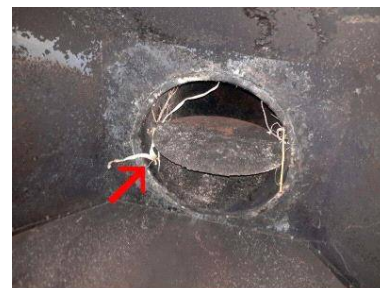
☐ ☒ ☐ Nest material.

Nesting material in chimney  
stack

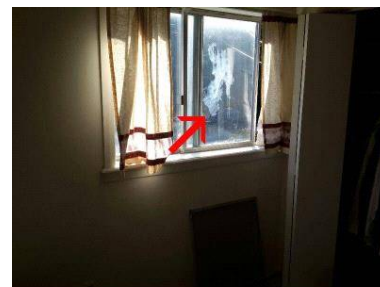
☐ ☒ ☐ At least one window or associated  
hardware in this room needs repair.  
The thermal seal is broken.  
Although it is keeping the elements  
out, it has a clouded appearance.  
This condition will worsen. There is  
no screen in place at the window.

Bad seal, missing screen

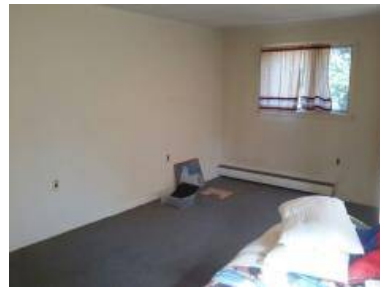
☒ ☐ ☐ General condition appears  
serviceable, There is some minor  
cracking in the sheetrock. Most  
likely this is due to slight settlement  
or shrinkage.

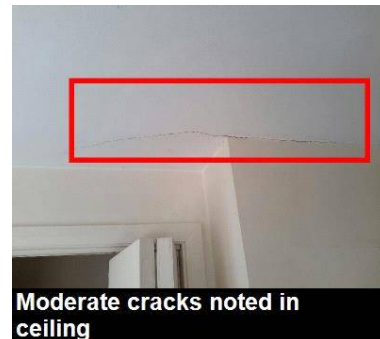
- ☐ ☒ ☐ General condition appears serviceable, There is some minor cracking noted. Be sure to take note of any future movement. Most minor cracking is due to shrinkage of the construction materials.

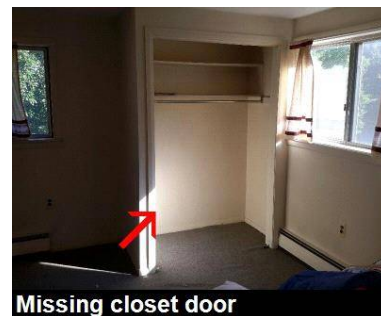
- ☐ ☒ ☐ The closet is not lighted, Closet door is missing.

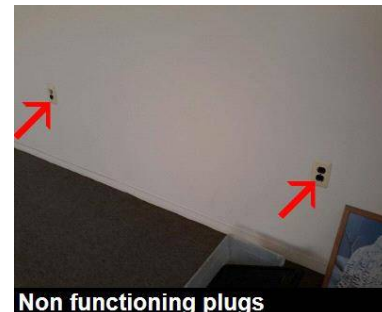
- ☐ ☐ ☒ Some outlets did not function.

Non functioning plugs

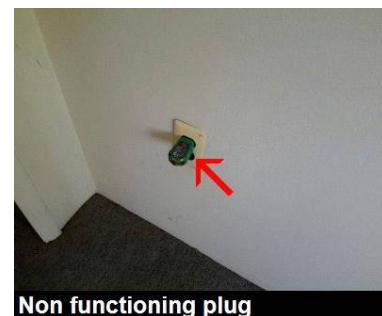
## Bedroom #2:

- OK MM RR  
☐ ☐ ☒ Some outlets did not function.

Non functioning plug

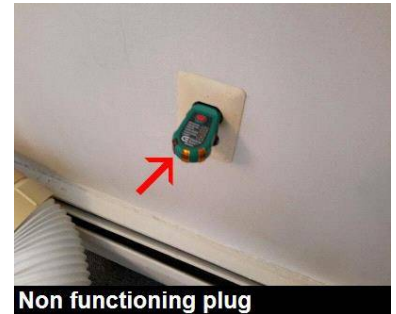
☐ ☐ ☒ Some outlets did not function.

Non functioning plug

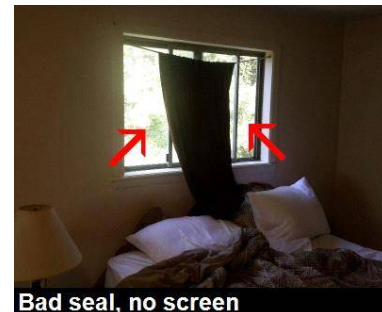
- ☐ ☒ ☐ At least one window or associated hardware in this room needs repair. The thermal seal is broken. Although it is keeping the elements out, it has a clouded appearance. This condition will worsen. The screen for this window needs repair.

Bad seal, no screen

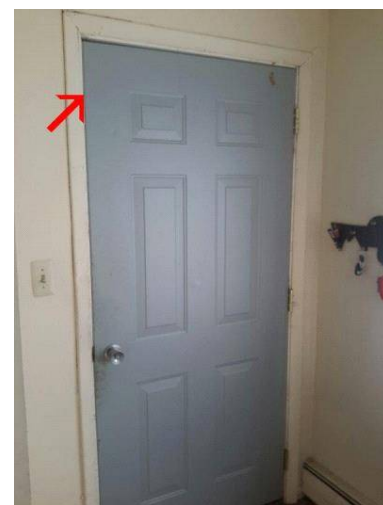
*Entry / Foyer / Hall:*

General condition appears serviceable, Hardware operational, Doorframes are not square. Some binding is noted.

Binding noted at top of the door

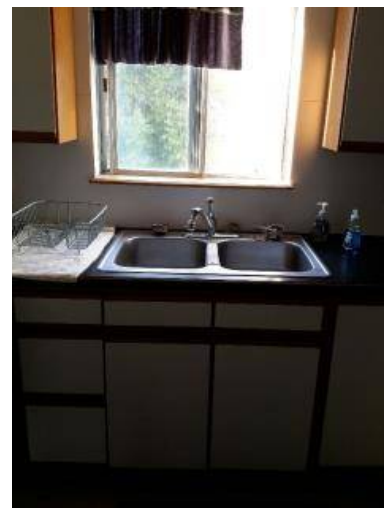
*Kitchen Interior:*☒ ☐ ☐

The screen for this window needs repair.

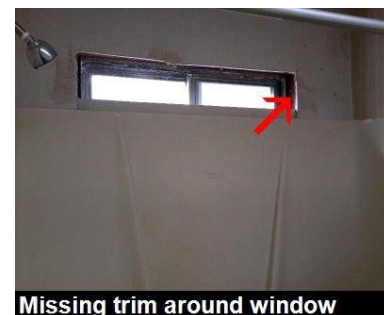
*Hall Bath:*☐ ☒ ☐

At least one window or associated hardware in this room needs repair. The window trim is damaged or missing. Window has been covered by shower wall liner. Damage is anticipated.

**Missing trim around window***Bath Between Bedrooms:*☐ ☒ ☐

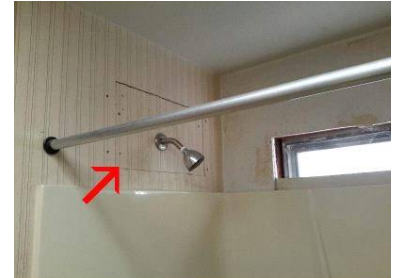
*Hall Bath:*

- OK MM RR  
☐ ☒ ☐ Repairs made around showerhead.

**Repairs made to wall around showerhead**

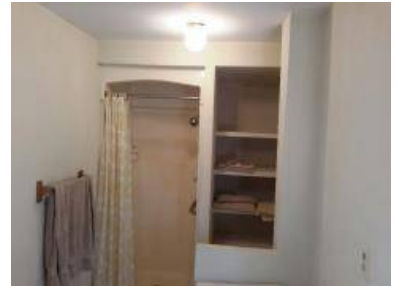
*Bath Between Bedrooms:*

There is some minor cracking in the sheetrock. Most likely this is due to slight settlement or shrinkage. Walls are in good condition with normal wear.

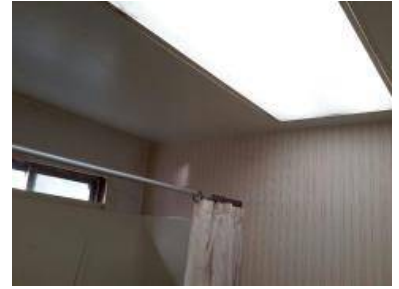
**Hall Bath:**

There is some minor cracking noted. Be sure to take note of any future movement. Most minor cracking is due to shrinkage of the construction materials. Ceilings are in good condition with moderate wear.

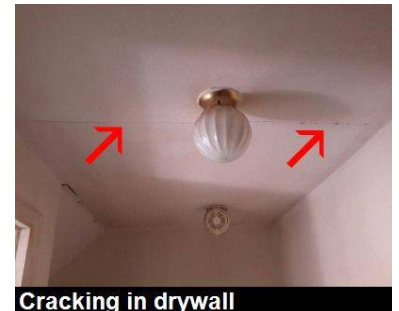
General condition appears serviceable, There is some minor cracking noted. Be sure to take note of any future movement. Most minor cracking is due to shrinkage of the construction materials.

**Cracking in drywall**

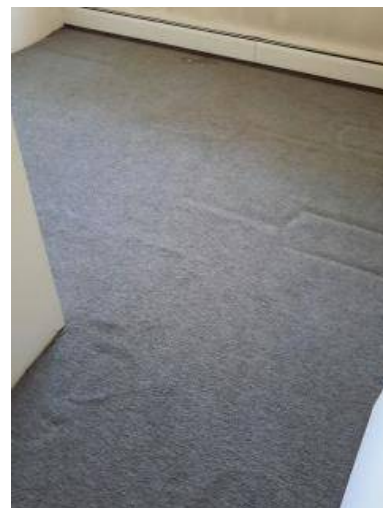
*Bedroom #2:*

OK MM RR  
☒ ☐ ☐ General condition appears serviceable, The floor covering material is carpet. Fair - Material is worn, with some age.

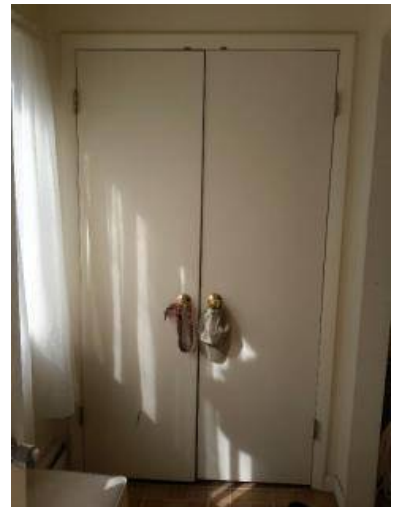
*Entry / Foyer / Hall:*

OK	MM	RR	
<input checked="" type="checkbox"/>	<input type="checkbox"/>	<input type="checkbox"/>	General condition appears serviceable.
<input checked="" type="checkbox"/>	<input type="checkbox"/>	<input type="checkbox"/>	General condition appears serviceable, The closet is not lighted.

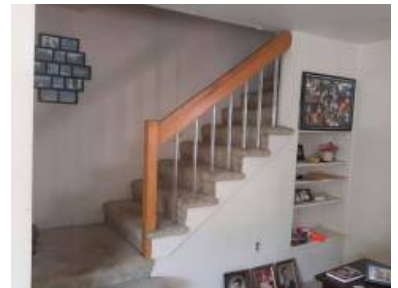
- OK MM RR  
☒ ☐ ☐ Interior stairs serviceable, Stair handrail serviceable.

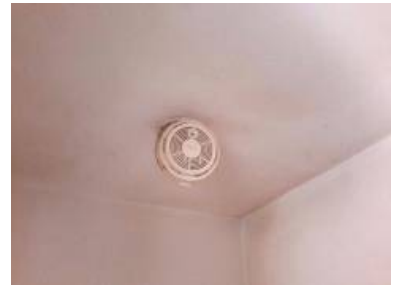
**Entry / Foyer / Hall:**

- ☐ ☐ ☒ Repairs are needed - There is a nonworking smoke detector in this room. For safety considerations, it needs to be repaired or replaced immediately.

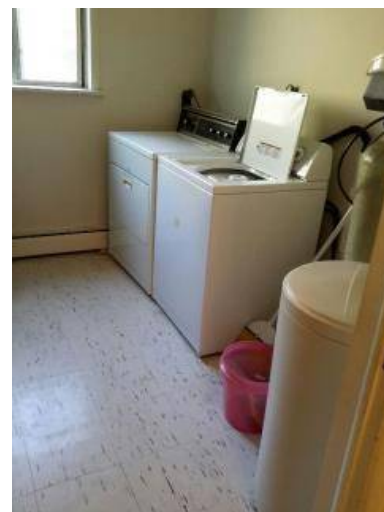
Laundry is located at the utility room on the 1st Floor.

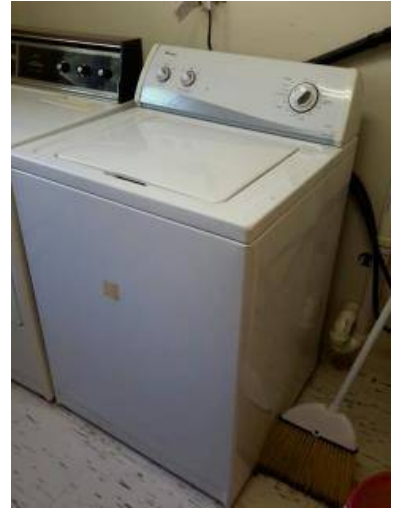
*Clothes Washer:*

☒ ☐ ☐ Brand, Amana, Appears serviceable, Appears more than 5 years old.

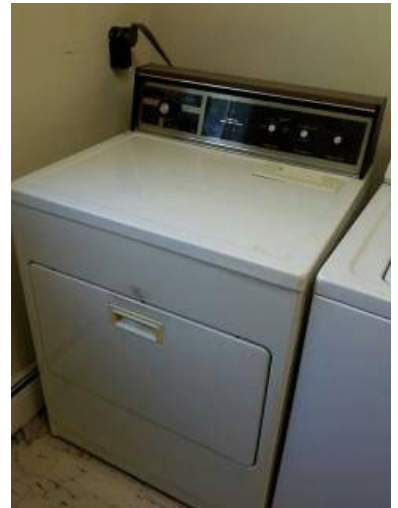
*Clothes Dryer:*

OK MM RR  
☒ ☐ ☐ Brand, Amana, Appears serviceable, Appears more than 5 years old, Electric model, There is only a 220-volt outlet provided for an electric dryer. If you intend to use a gas clothes dryer, you will need to have a gas line installed.

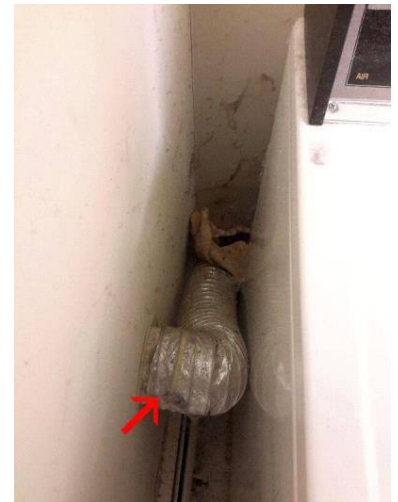
*Dryer Vent:*

☐ ☐ ☒ A dryer vent is provided, Replace flexible dryer vent with solid pipe.

**Replace flex line with solid pipe**

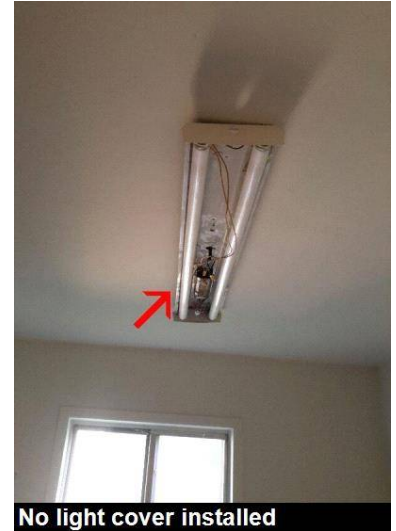
*Switches & Fixtures:*

- ☐ ☒ ☐ Cover not installed at time of inspection.

**No light cover installed**

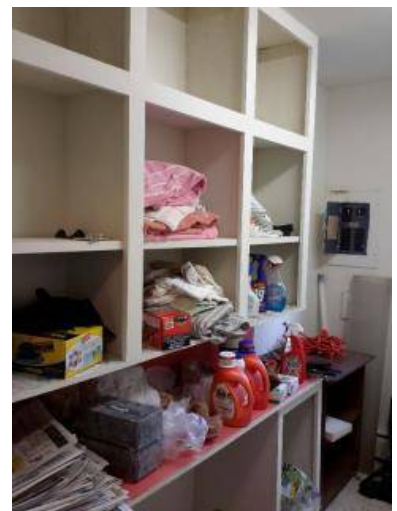
*Walls:*

General condition appears serviceable.
